# A Review of Recent Distributed Optical Fiber Sensors Applications for Civil Engineering Structural Health Monitoring

**Abstract:** The present work is a comprehensive collection of recently published research articles on Structural Health Monitoring (SHM) campaigns performed by means of Distributed Optical Fiber Sensors (DOFS). The latter are cutting-edge strain, temperature and vibration monitoring tools with a large potential pool, namely their minimal intrusiveness, accuracy, ease of deployment and more. Its most state-of-the-art feature, though, is the ability to perform measurements with very small spatial resolutions (as small as 0.63 mm). This review article intends to introduce, inform and advise the readers on various DOFS deployment methodologies for the assessment of the residual ability of a structure to continue serving its intended purpose. By collecting in a single place these recent efforts, advancements and findings, the authors intend to contribute to the goal of collective growth towards an efficient SHM. The current work is structured in a manner that allows for the single consultation of any specific DOFS application field, i.e., laboratory experimentation,

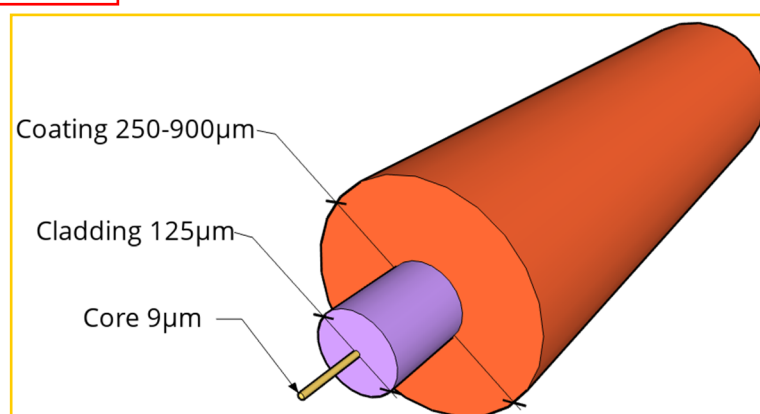
**Figure 1.** 3D illustration of an optical fiber cross-section.

Focusing in particular on OFS, these are dielectric devices used to confine and guide light. They consist of several layers: fiber core, cladding and, occasionally, an external jacket aimed at providing mechanical resistance to the fiber (an example is provided in Figure 1).

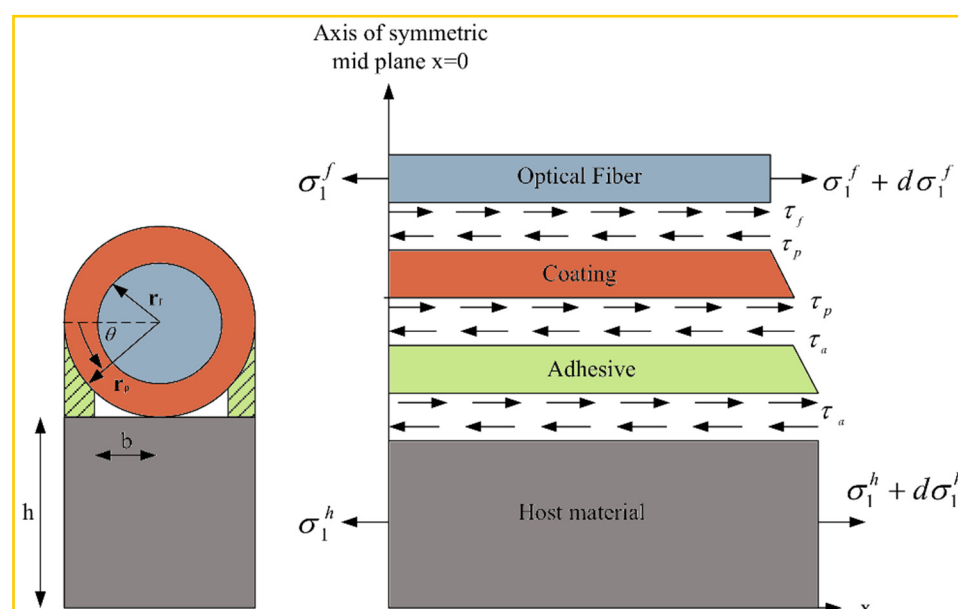
**Figure 4.** Free body diagram for the symmetrical section of the optical fiber and the substrates together with their relative shear transfer (adapted from [40]).

Ideally, the strains measured by a DOFS silica core should be equivalent to the actual strains present in the host structure on which the former is bonded. If this requirement was fully met then both DOFS structural monitoring and laboratory structural investigation would simply boil down to analyzing the OBR's output data, no matter how minute the object of investigation is or how accurate the measurement requirements are. Unfortunately, this is not always the case. Indeed, the packaging and the installation of the sensors involves intermediate layers (i.e., protective coatings and adhesive layers) whose presence leads to the failure of the complete strain transfer from the host material to the sensing fiber [19]. Instead, some of the energy is converted to the shear and normal deformations of the intermediate layers (as well illustrated by Her and Huang [40] in Figure 4) thus leading to strain transfer errors.

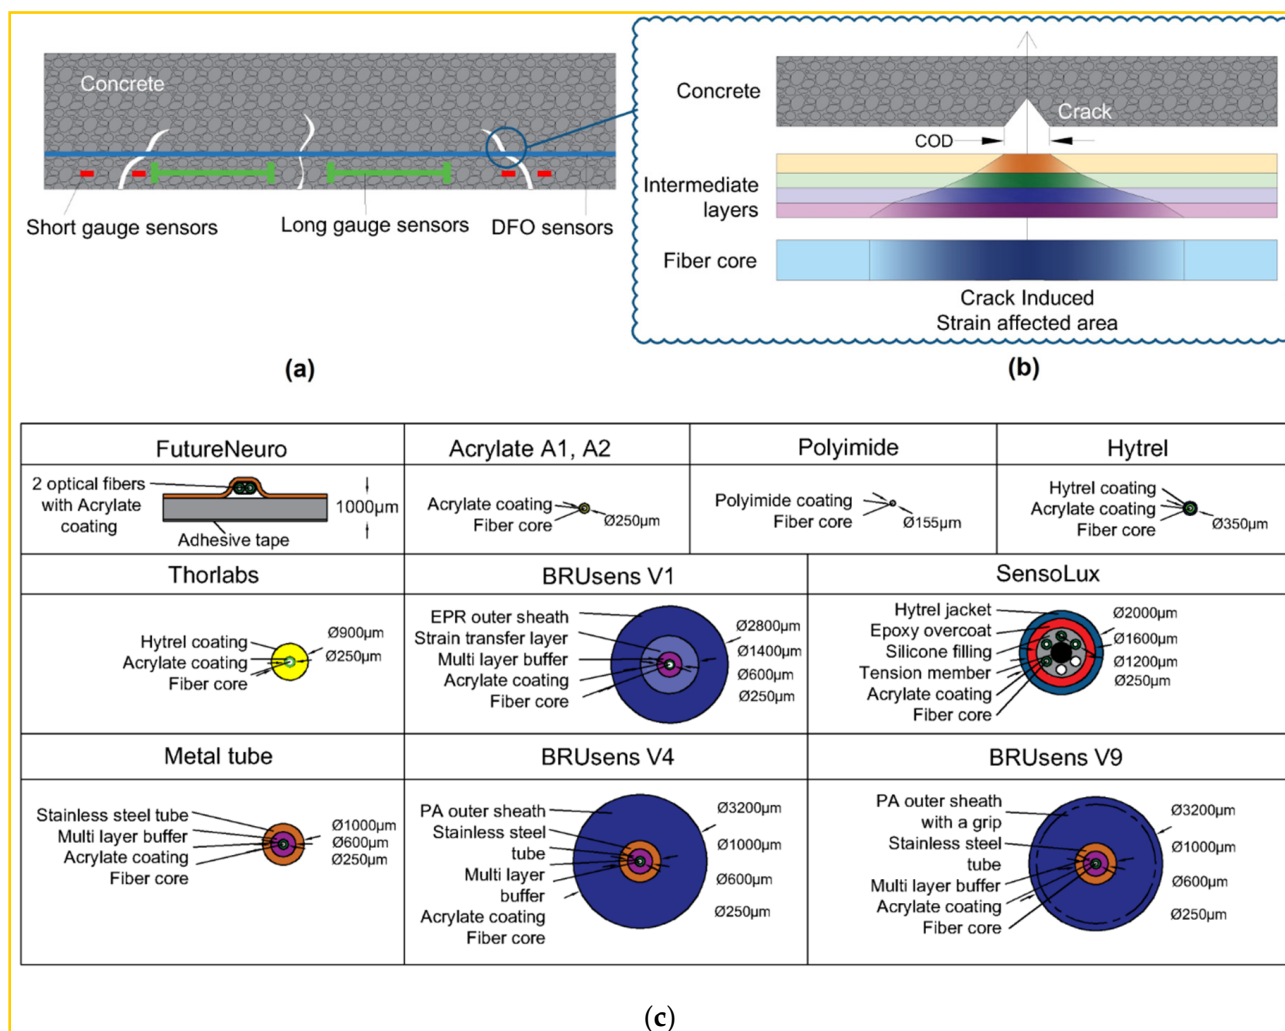
**Figure 5.** Crack detection using DOFS techniques: (a) Comparison of the traditional sensors, (b) strain transferring between layers and (c) the tested cables (adapted from [44]).

In response to some of the above lackings, the authors used in their test multiple kinds of OFDR DOFS cables (see Figure 5c). The experimental results reportedly estimated correctly the crack openings and led to successful monitoring of the optical cable responses through the strain lag parameter. A final key observation worth reporting here was the Polyimide-cladded cables' strain lag parameters  $\lambda$  varying around  $260 \text{ m}^{-1}$  whilst the others between  $20 \text{ m}^{-1}$  and  $60 \text{ m}^{-1}$ . This meant that the Polyimide fiber reported crack-induced strain distributions 5 to 15 times higher than the other tested cables, which allowed for the accurate detection of tiny crack propagations.

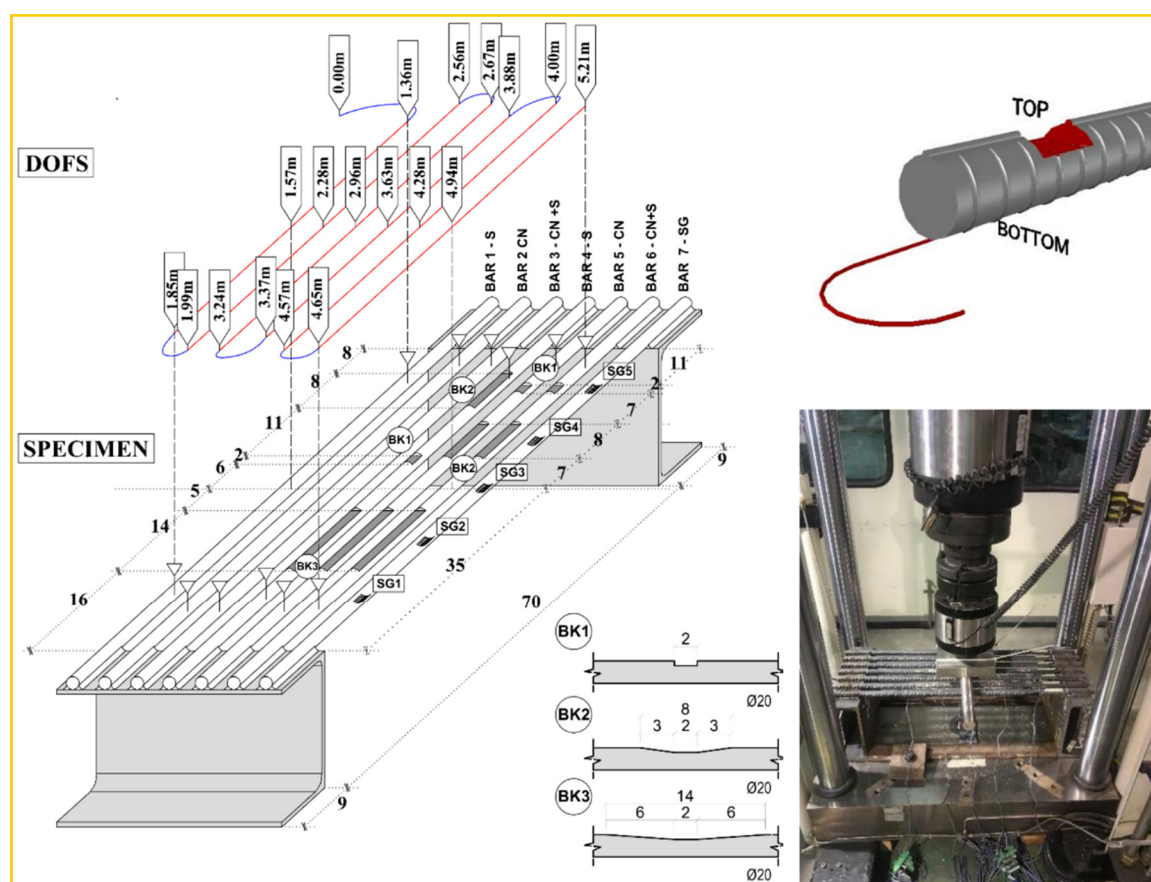
**Figure 6.** Test setup: three-dimensional specimen detailing and photography [48].

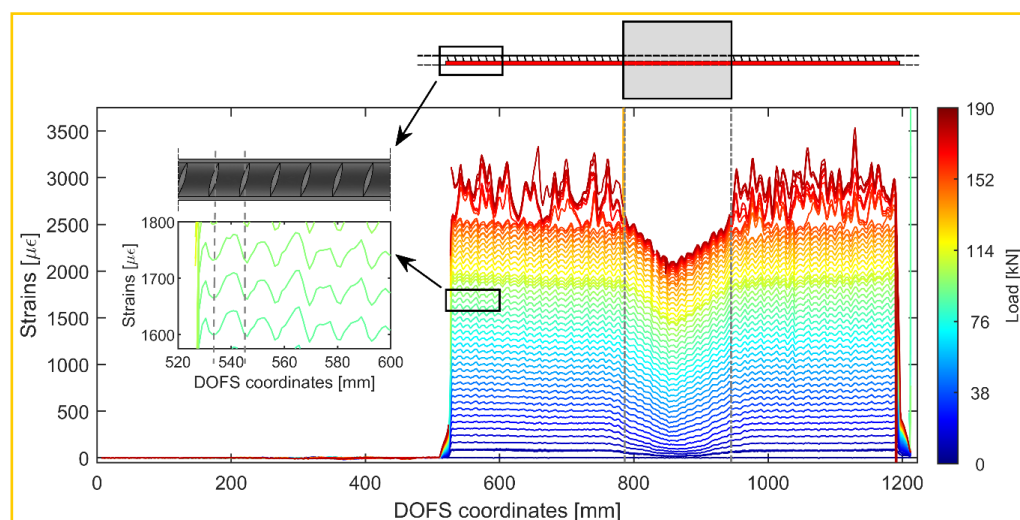
**Figure 7.** Strain profiles of a  $15 \times 15 \times 210 \text{ mm } \text{Ø}20$  Reinforced Concrete (RC) tie test with the DOFS bonded with a combination of groove, cyanoacrylate and silicone [49].

Additionally, as also visible in Figure 7, the oscillations of the profiles, easily confusable with signal noise, were stated to be the influence of the transversal rib on the tensile performance of the rebar. Additionally, it was observed on all the specimens that the magnitude of the defined rib-induced noise became increasingly larger (see Figure 8) with the load thus increasingly disturbing the sought-after signal, that is the strain profile.

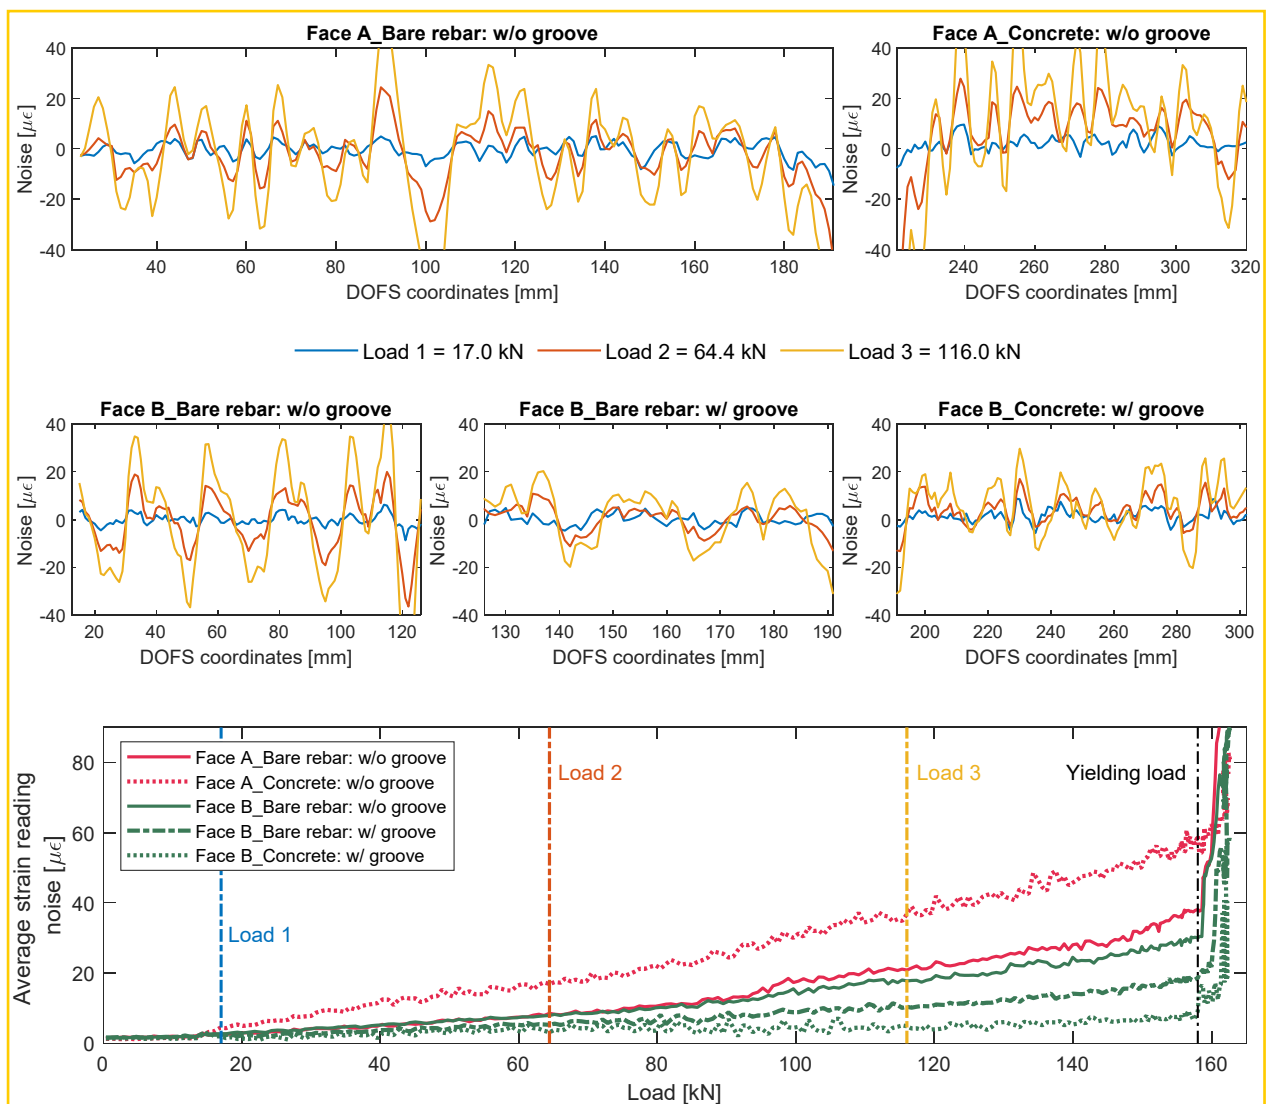
**Figure 8.** Influence of the rib pattern on the steel strain profiles during the double pull-out test of the RC tie  $15 \times 15 \times 240$  mm Ø20 (top five figures). Relative average reading noise (bottom) [49].

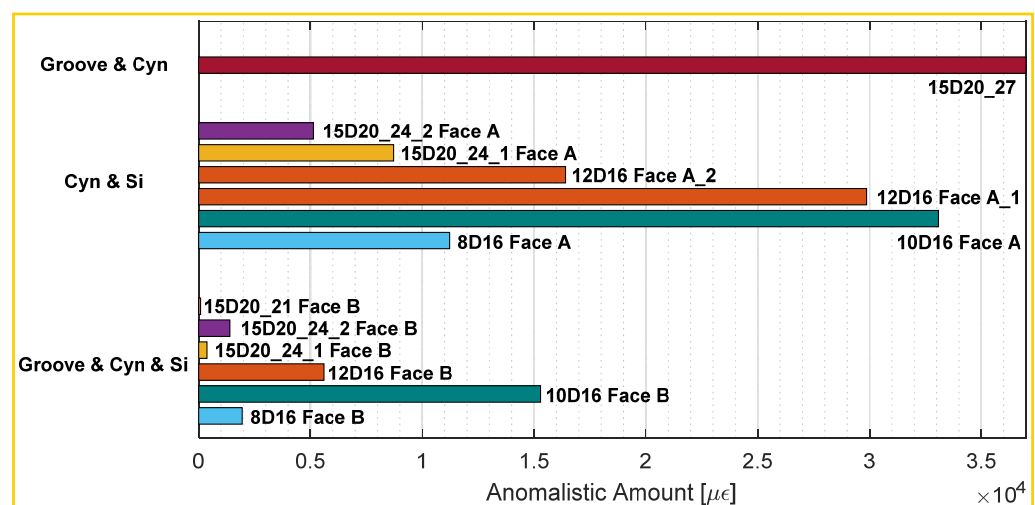
**Figure 9.** Total amount of anomalistic readings grouped per bonding technique [49].

The authors continued reporting an unexpected phenomenon, possibly connected to the under-performance of the bonding techniques, which caused an alteration of the DOFS strain readings whenever the fiber was in the presence of extra bending-induced tension (smoothing out strain profiles) and/or monitoring strains in cracked cross-sections (magnifying their amount). Additional work on the involved transfer mechanisms could be the key to such phenomena. Finally, it was asserted that, whilst none of the studied bonding techniques could completely guarantee the removal of all SRAs, the combination of a longitudinally incised groove, cyanoacrylate and silicone was the bonding technique that led to the smallest amount of SRA thus preserving the readability and reliability of the strain data (see Figure 9).

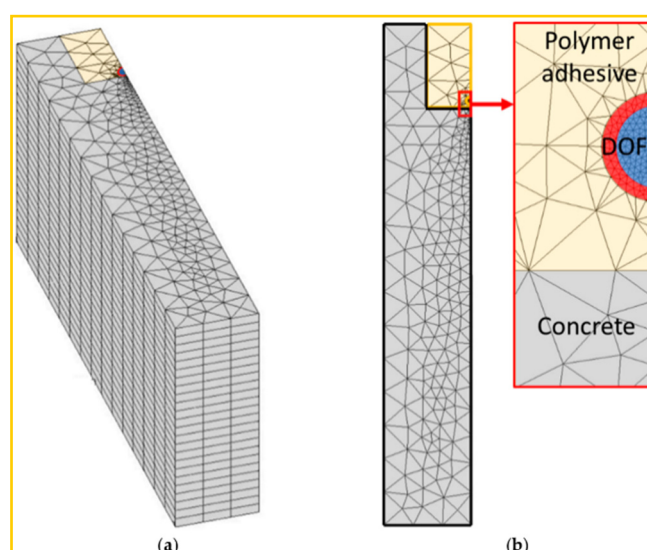
**Figure 10.** Finite element mesh of (a) the 3D geometry and (b) the cross-sectional view of the system [42].

Alj et al. [42] investigated the strain response of thick-coated DOFS sealed in a groove on the surface of a concrete structure using a polymer adhesive and aimed to identify optimal conditions for crack monitoring. Initially, a Finite Element Model was developed (see Figure 10) to understand the strain transfer process between the DOFS core and the host structure which showed that the softer the adhesive is, the lower the strain transferred to the DOFS glass core due to redistribution over a broader length of the sensor (similarly to what was observed in [48–50]).

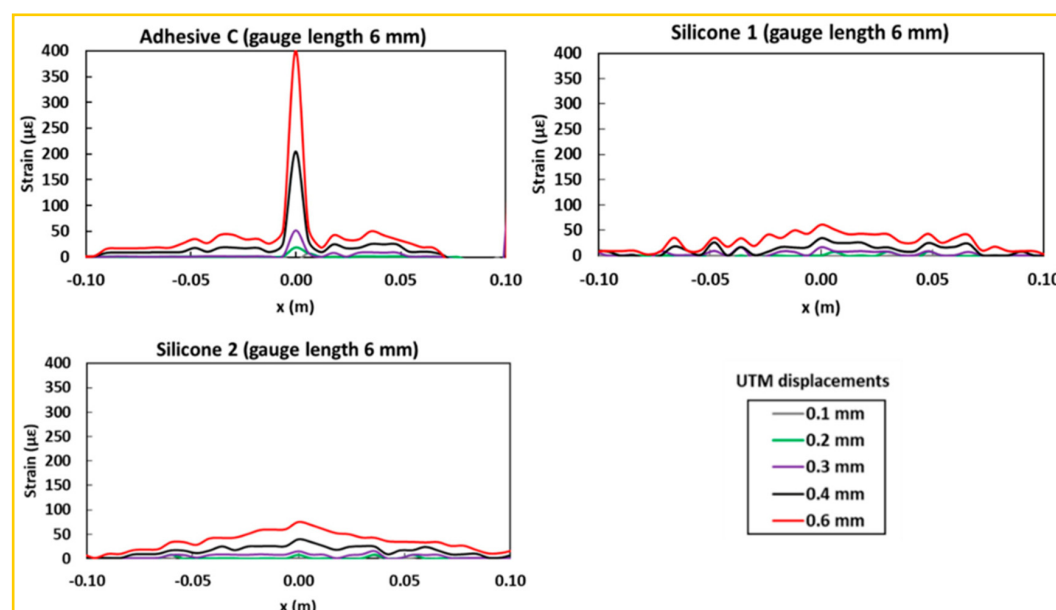
**Figure 11.** Strain profiles recorded by DOFS bonded to the concrete specimen with three soft adhesives (Bi-component epoxy, Mastic silicone and Silicone rubber) [42].

The DOFS bonded with Bi-component epoxy revealed the development of a strain peak in the central part of the profile from the actuator displacement of 0.2 mm. DOFS bonded with the two silicone adhesives, instead, did not show clear peaks development but rather small triangular shaped profiles visible only from the actuator displacement of 0.3 mm. Indeed, as already observed in [48,50], the very low stiffness of these silicone adhesives (about 5 times lower than that of the Bi-component epoxy) favored the diffusion of the originally concentrated stress over the entire length of the bonded DOFS. Consequently, the authors suggested that the adhesive stiffness should be optimized to ensure a compromise between protective function and crack monitoring performance. Alj et al. finally generalized the above FEM to describe the strain response of bonded DOFS in the presence of crack and an analytical expression relating a DOFS peak strain to the crack opening was proposed.

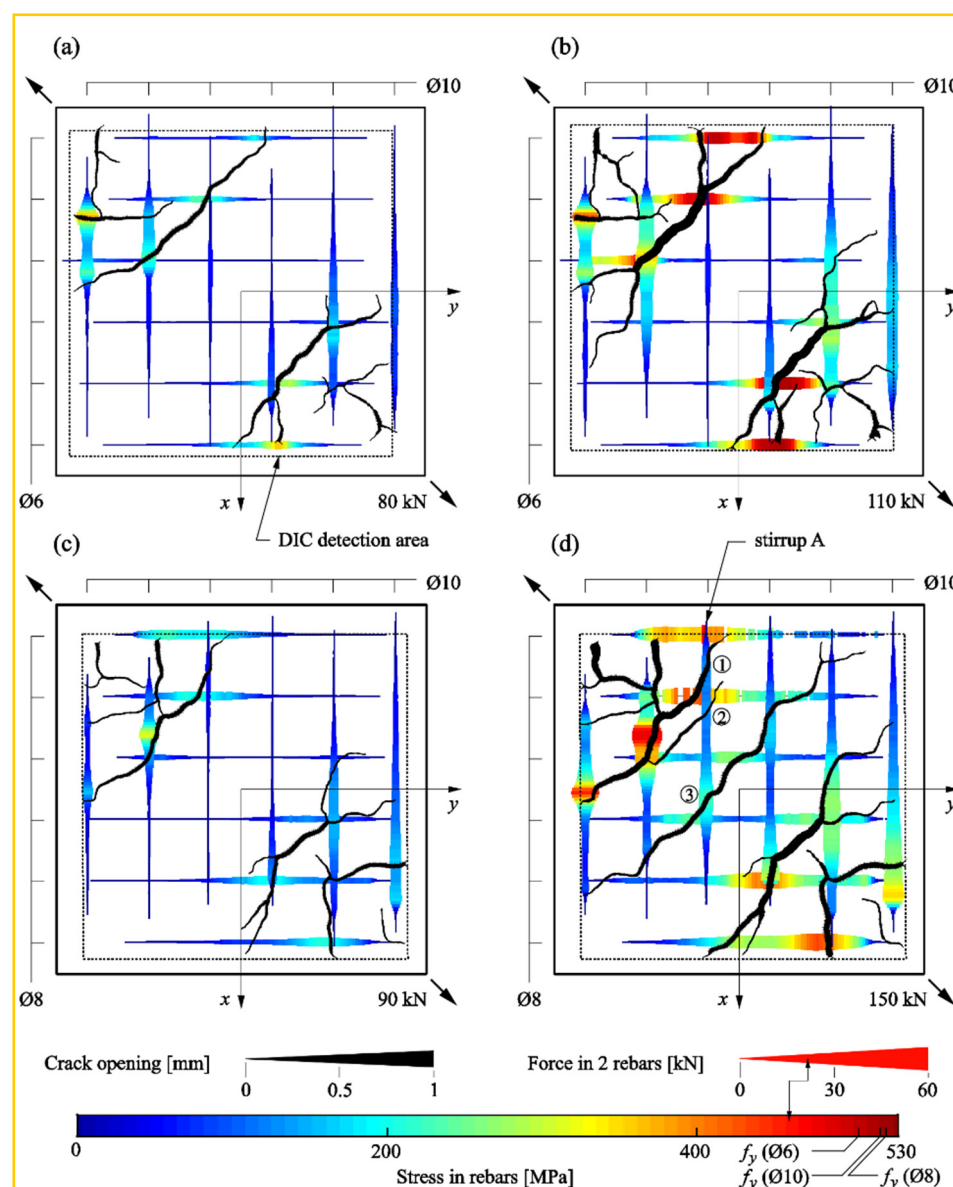
**Figure 12.** Crack locations and openings, steel stresses and forces in front layers of stirrups for Panel 1 at (a) 80 kN and (b) 110 kN as well as for Panel 2 at (c) 90 kN and (d) 150 kN [54].

The former explored the combined use of DIC and OFDR DOFS for the strain measurements of two  $600 \times 600 \times 125$  cm reinforced panels subjected to diagonal tension. The OFDR DOFS were glued with epoxy inside  $1 \times 1$  mm grooves carved along both legs of every stirrup, summing up to 24 measuring lines across the whole specimen. As visible in Figure 12, the DOFS-sampled reinforcement strains correlated well with the position and opening of the cracks (monitored by the DIC) proving the compatibility and potential of DIC and DOFS to measure phenomena like bond, crack behavior and shear transfer.

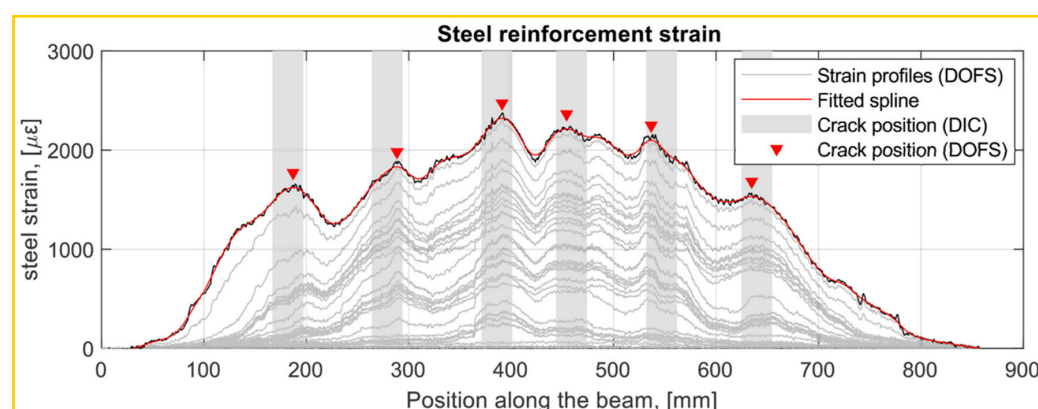
**Figure 13.** Multiple strain profiles from the DOFS where the red triangular markers indicate the determined crack position based on the strain profile at maximum load and the grey shaded area correspond to position determined from the Digital Image Correlation (DIC) [59].

Berrocal et al. [59], for example, aimed at assessing the suitability and accuracy of thin polyamide-cladded OFDR DOFS for the crack monitoring of RC beams subjected to three-point bending tests (monotonic and cyclic loading) in addition to determining the crack location and width evolution over time. The latter was achieved by means of comparison between DOFS reinforcement strain profiles and externally sampled DIC measurements. Low-bend loss polyamide-coated DOFS (155  $\mu\text{m}$  diameter) were bonded directly to the rebar's surface, along one of the longitudinal ridges, with cyanoacrylate adhesive before being protected by a silicone layer. The comparison of the crack location obtained from DOFS and DIC revealed that most of them were located within an acceptable range of  $\pm 3\text{ cm}$  from each other (as visible in Figure 13).

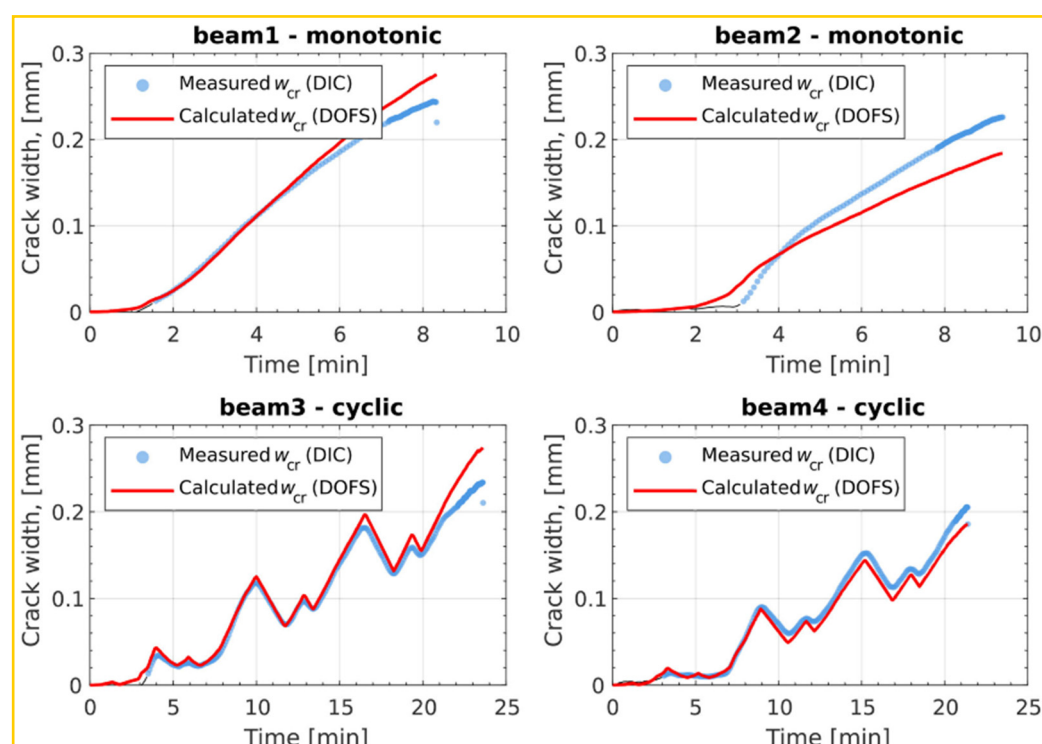
**Figure 14.** Comparison between the crack width measured by the DIC and calculated from the DOFS measurements [59].

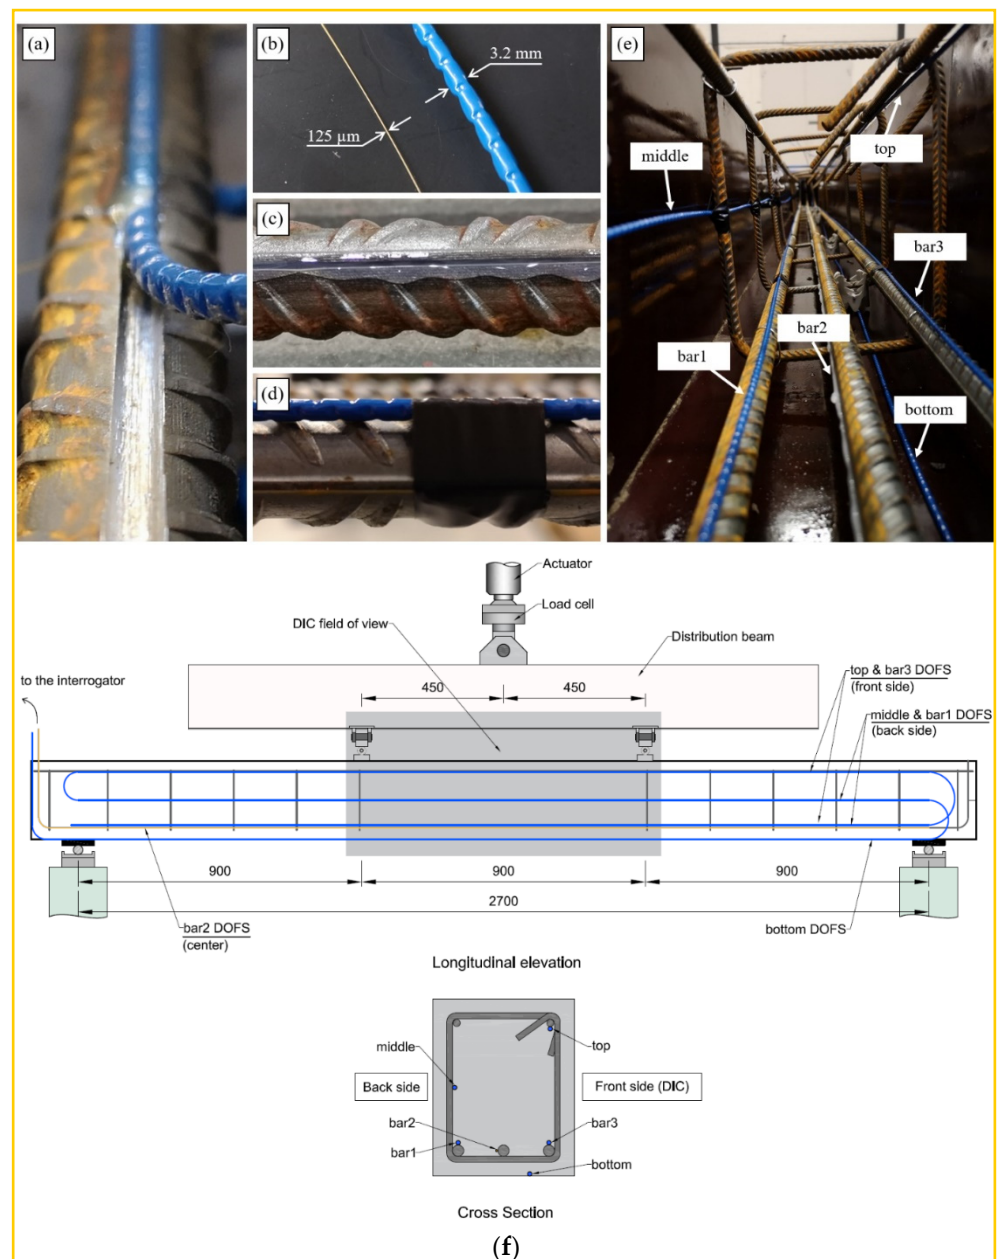
**Figure 15.** Installation of the DOFS: (a) installation of robust DOFS cable in a reinforcement bar by inserting it into a previously milled groove; (b) comparison of thin and robust DOFS; (c) installation of thin DOFS on the surface of a reinforcement bar by bonding it with cyanoacrylate adhesive and protecting it with silicone; (d) installation of robust DOFS on the surface of a reinforcement bar by mechanically anchoring the cable to the reinforcement with electric tape; (e) multi-layer configuration of embedded DOFS in the beam specimens and (f) loading setup and DOFS installation configuration for the RC beam specimens (adapted from [60]).

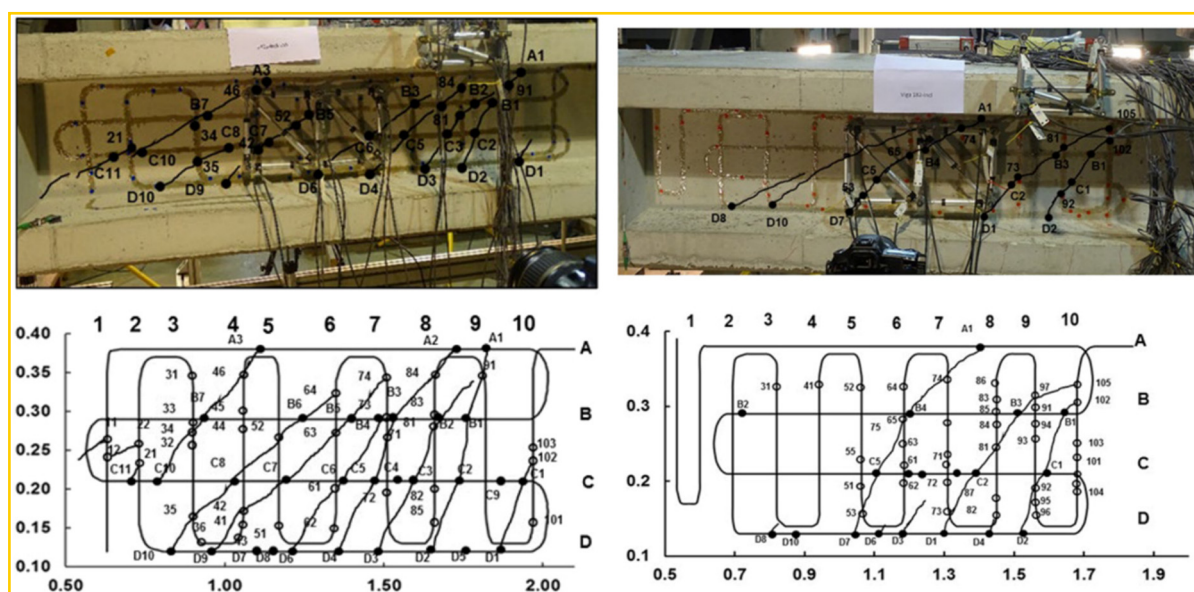
Figure 16. Real cracking pattern and obtained with DOFS in two different beams (adapted from [64]).

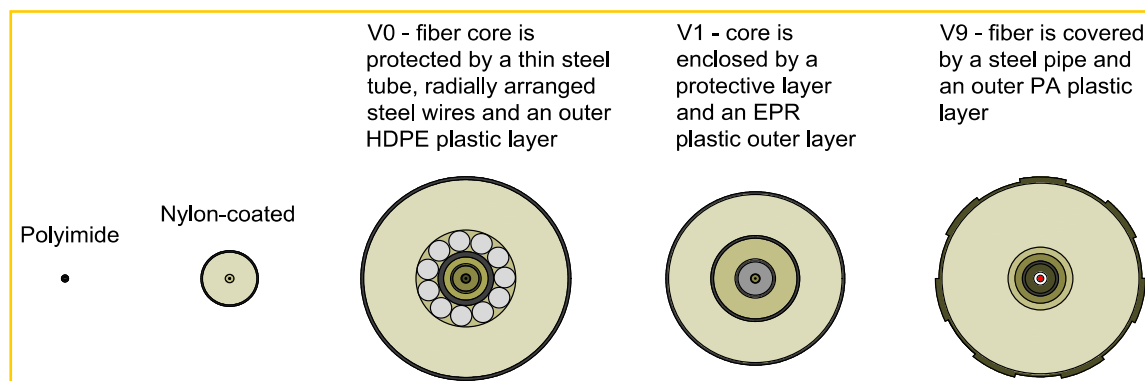
Figure 17. DOFS cables used in [66].

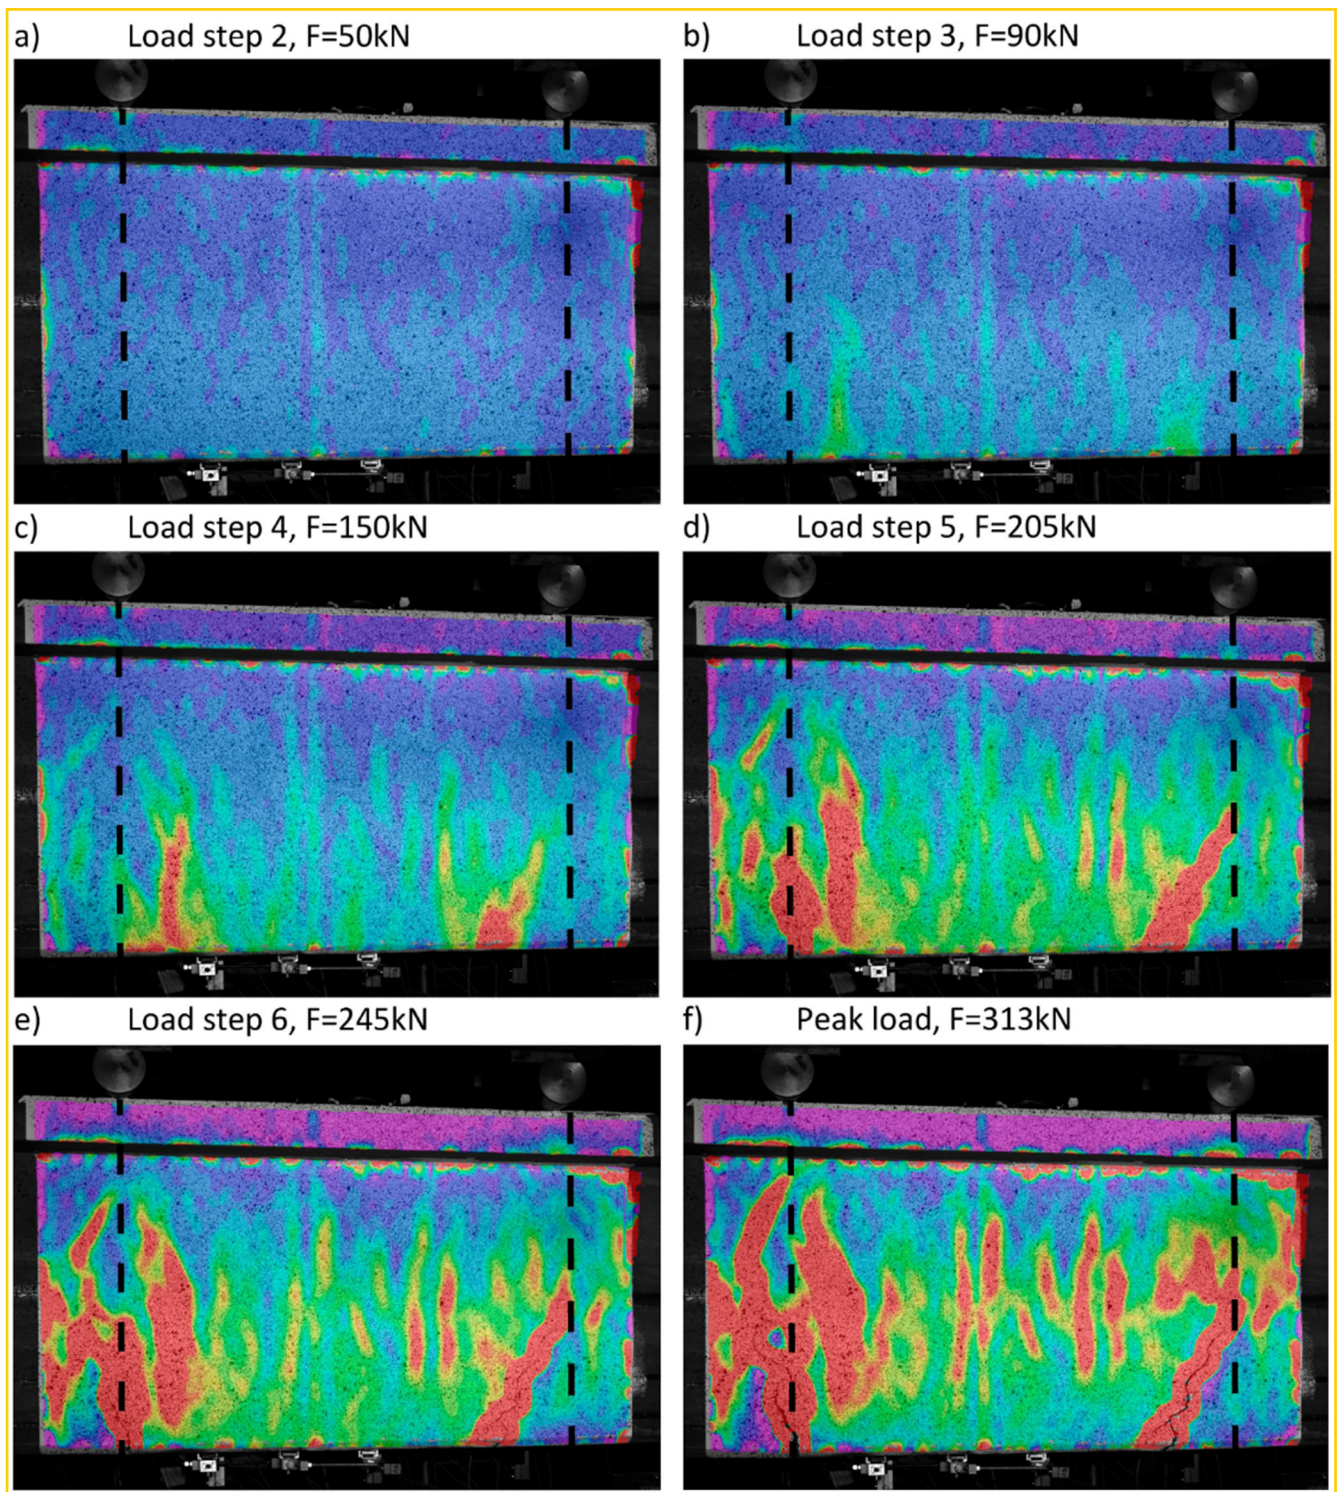
Figure 18. DOFS-integrating DIC strain distributions at different load steps [68].

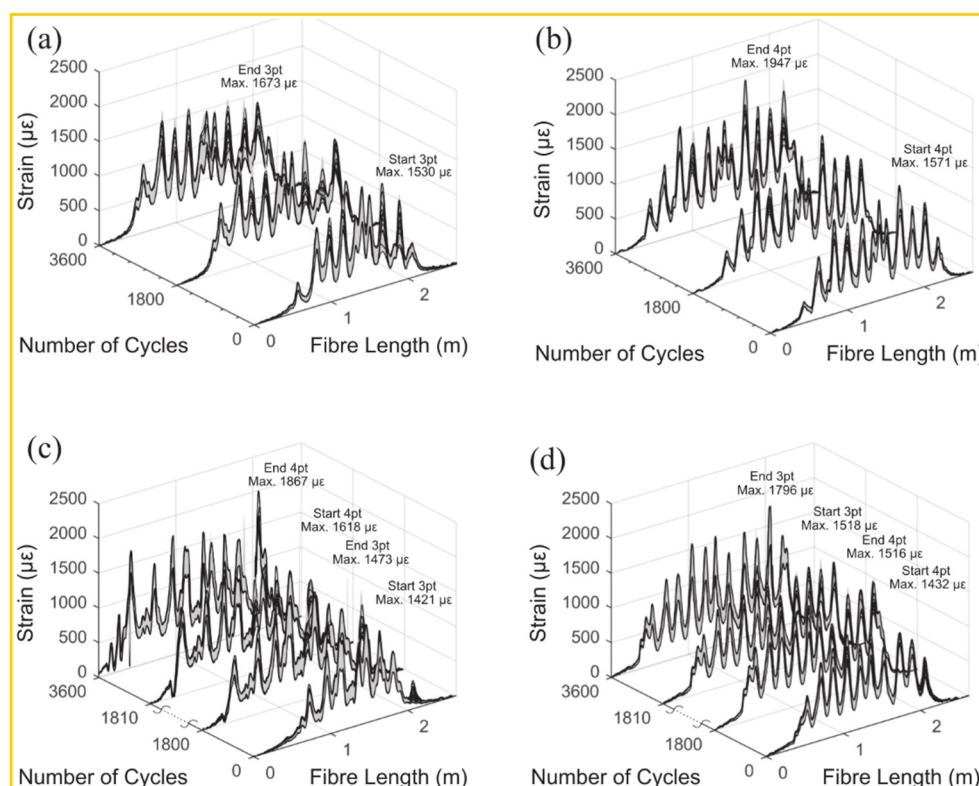
**Figure 19.** Strain along the bottom reinforcement during cycling for four deep beam specimens [69].

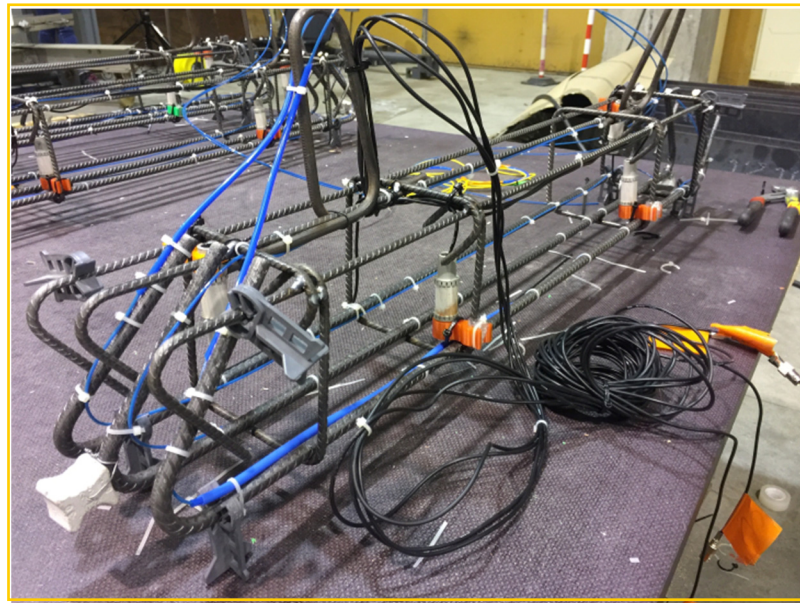
**Figure 20.** Ultra Sonics (US) and DOFS sensors attached to the rebars before casting of concrete [71].

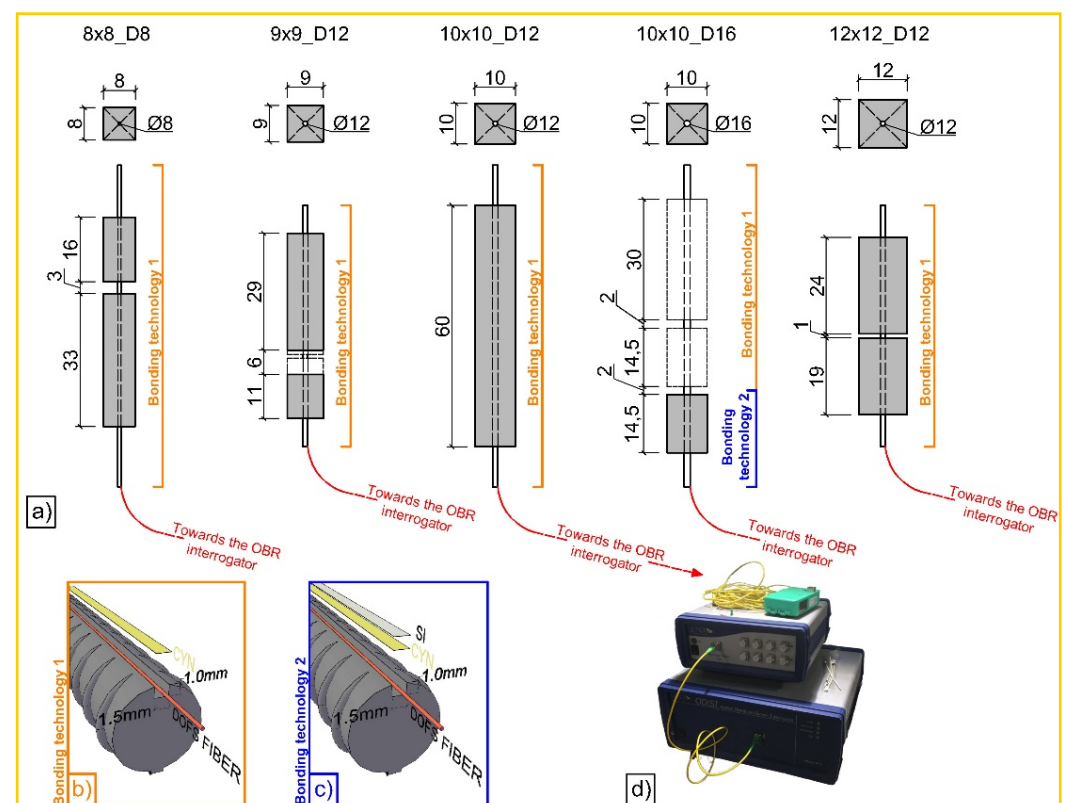
**Figure 21.** (a) Tested RC ties' with their respective bonding technologies, with (c) and without (b) the addition of a protective silicone layer. The DOFS-instrumented rebars were monitored by means of an (d) ODISI-A OBR interrogator [77].

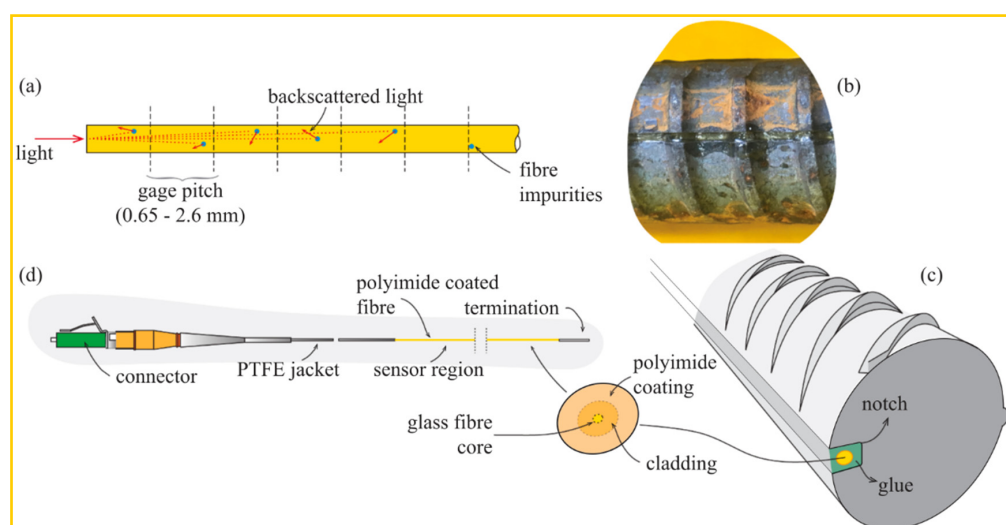
**Figure 22.** (a) Back-scattering mechanism due to fiber core impurities, (b) view of the fiber-optic sensor glued to a steel rebar, (c) sketch of the fiber optical cable placed in the groove and adhering to the steel due to two-component glue and (d) description of the fiber optic cable structure with angle polished connector on one side and termination (which avoids light reflection) on the opposite [78].

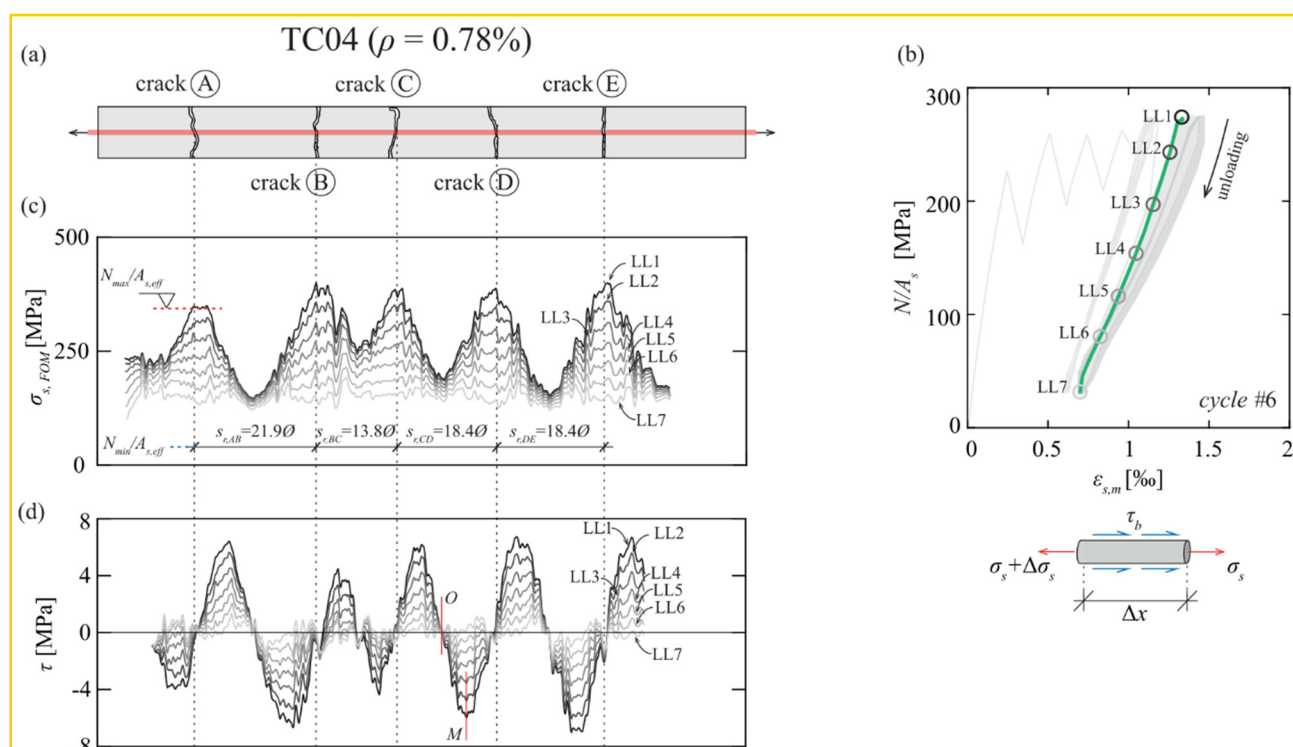
**Figure 23.** Tensile tests—specimen TC04: (a) cracking pattern in the cyclic loading phase, (b) stress-strain relationship for all cycles (in grey) and cycle #6 (in green) indicating load levels, (c) profiles of stresses, calculated on the basis of the measured DOFS (here defined as FOM) strains and (d) bond stresses  $\tau$  profiles along the steel rebar (adapted from [78]).

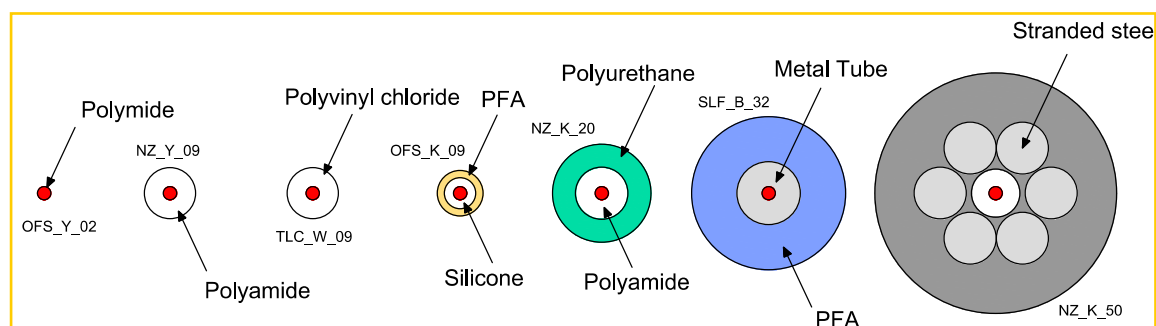
**Figure 24.** DOFS cables used in [79].

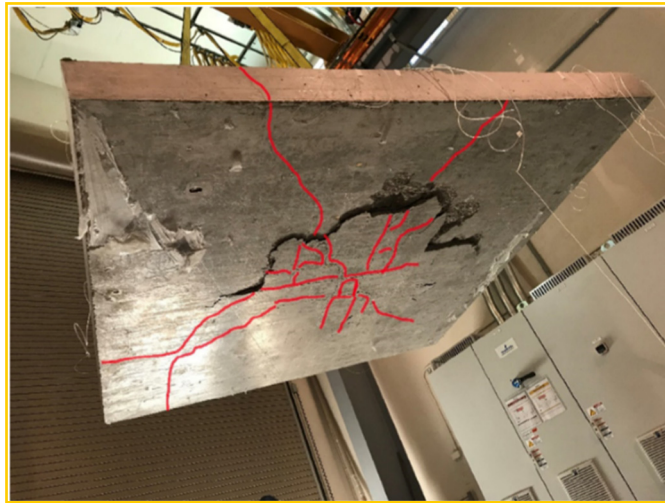
**Figure 25.** Specimen failure due to punching shear and its crack pattern [86].

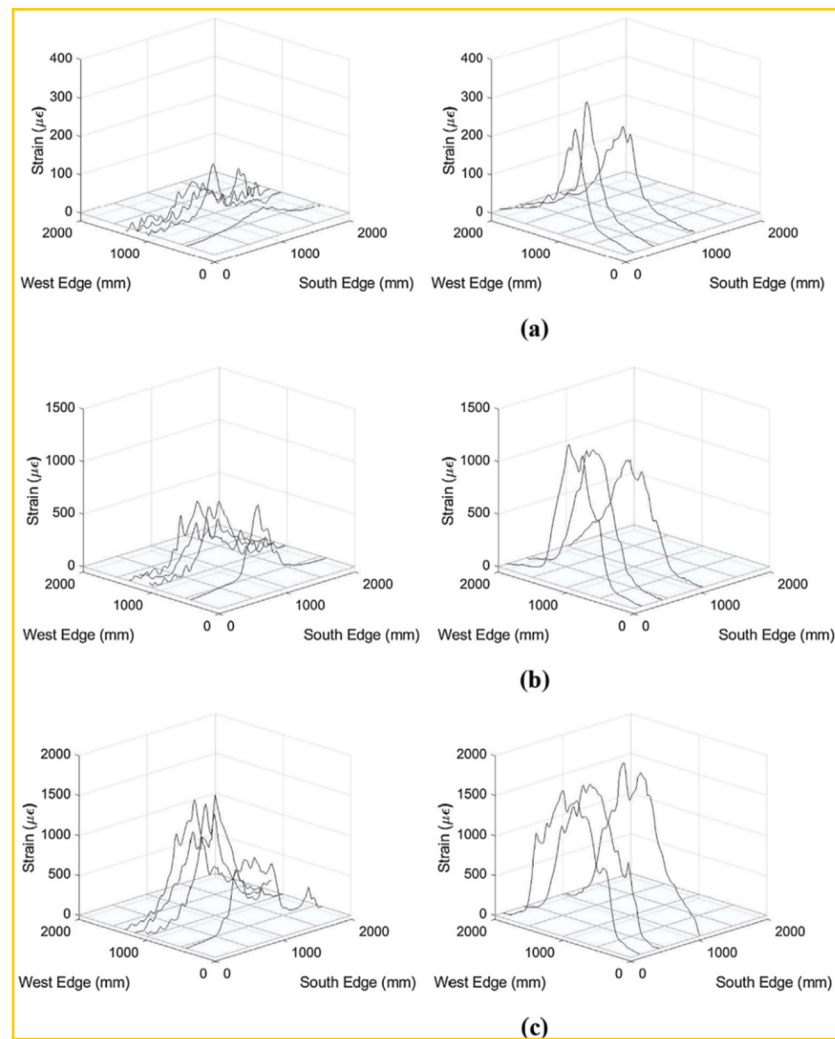
**Figure 26.** Slab 3-C-45 DOFS strains: (a) 50 kN (b) 100 kN (c) 150 kN (adapted from [86]).

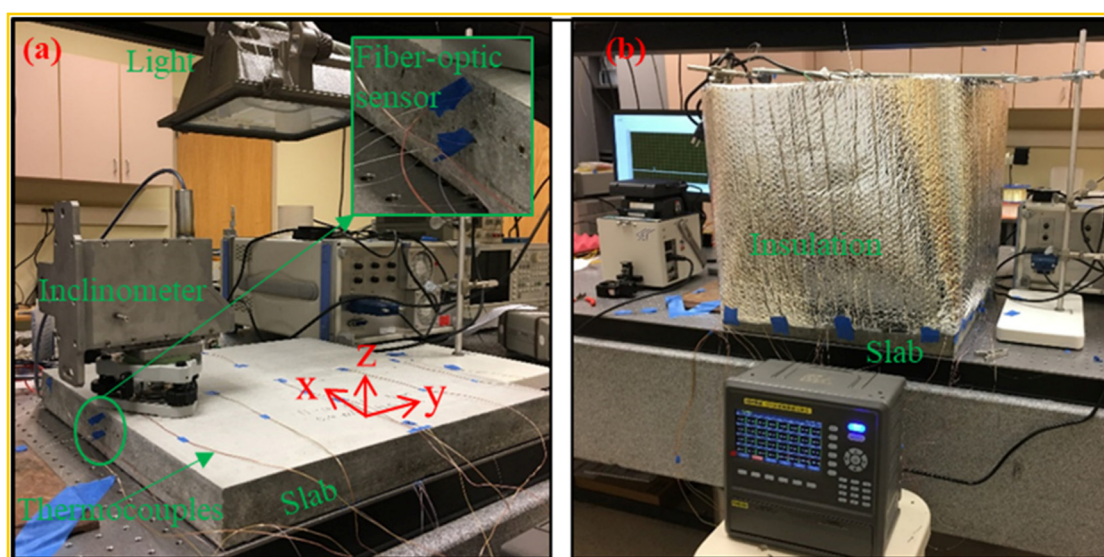
Figure 27. Test setup: (a) instrumented test slab, (b) testing with surrounding insulation [88].

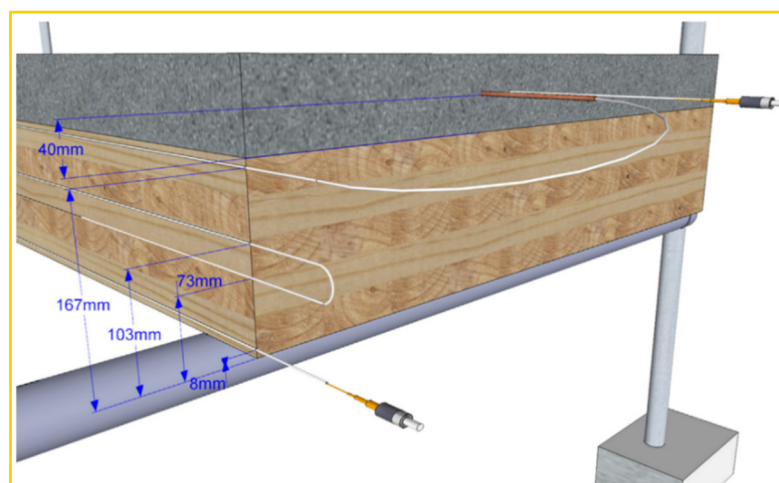
**Figure 28.** Fiber arrangement for the Timber–Concrete Composite (TCC) slab monitoring [89].
