# A Review of Recent Distributed Optical Fiber Sensors Applications for Civil Engineering Structural Health Monitoring

**Abstract:** The present work is a comprehensive collection of recently published research articles on Structural Health Monitoring (SHM) campaigns performed by means of Distributed Optical Fiber Sensors (DOFS). The latter are cutting-edge strain, temperature and vibration monitoring tools with a large potential pool, namely their minimal intrusiveness, accuracy, ease of deployment and more. Its most state-of-the-art feature, though, is the ability to perform measurements with very small spatial resolutions (as small as 0.63 mm). This review article intends to introduce, inform and advise the readers on various DOFS deployment methodologies for the assessment of the residual ability of a structure to continue serving its intended purpose. By collecting in a single place these recent efforts, advancements and findings, the authors intend to contribute to the goal of collective growth towards an efficient SHM. The current work is structured in a manner that allows for the single consultation of any specific DOFS application field, i.e., laboratory experimentation,

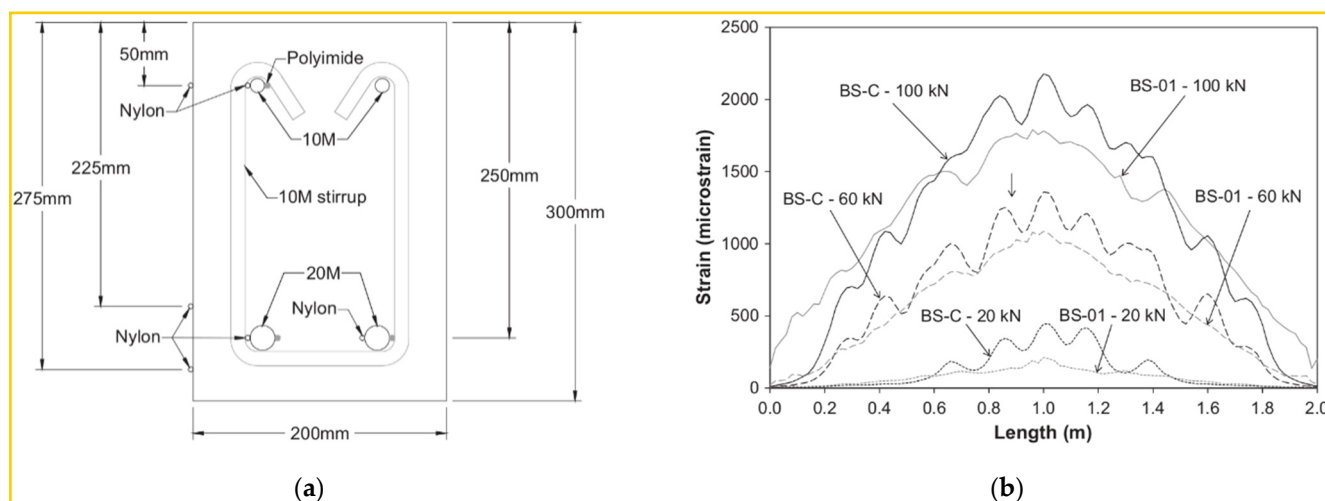
**Figure 29.** (a) Specimen's cross-sectional layout and (b) comparison of the nylon bottom DOFS measured strains between a non-corroded control beam (BS-C) versus a corroded one (BS-01) for three applied load steps, 20 kN, 60 kN and 100 kN (adapted from [90]).

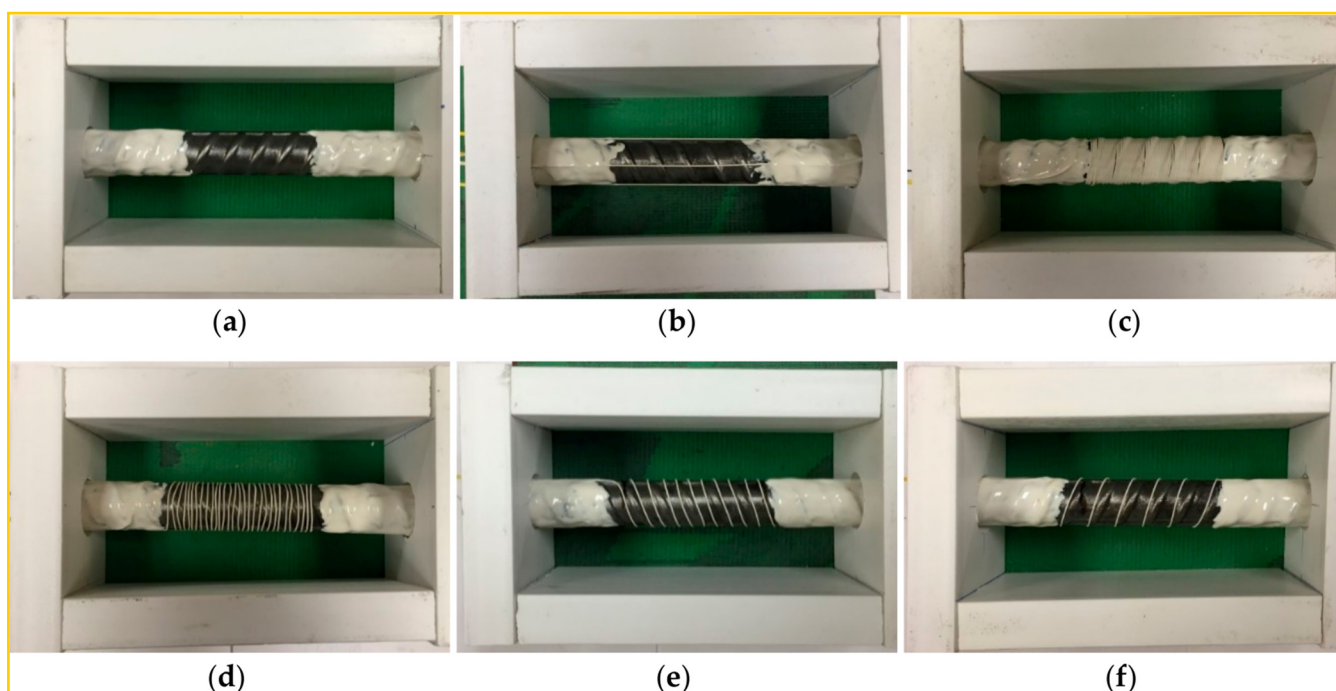
**Figure 30.** Photograph of the DOFS deployment on the steel bars: (a) Reference bar (b) L4 longitudinal deployment, (c) S0 spacing 0 mm (d) S2 spacing 2 mm (e) S5 spacing 5 mm and (f) S10 spacing 10 mm [93].

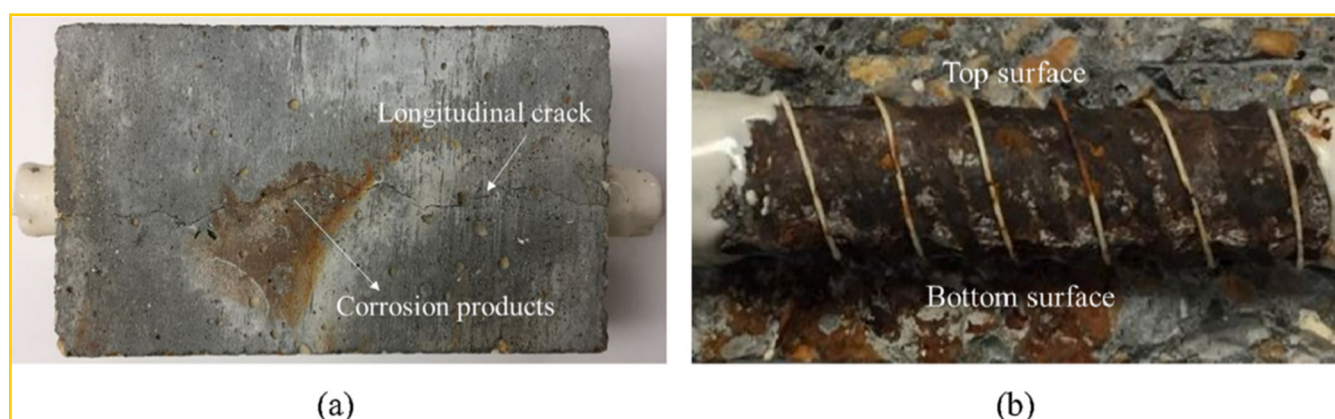
**Figure 31.** (a) Photography of the tested specimen and (b) cut section along the steel corroded bar [23].

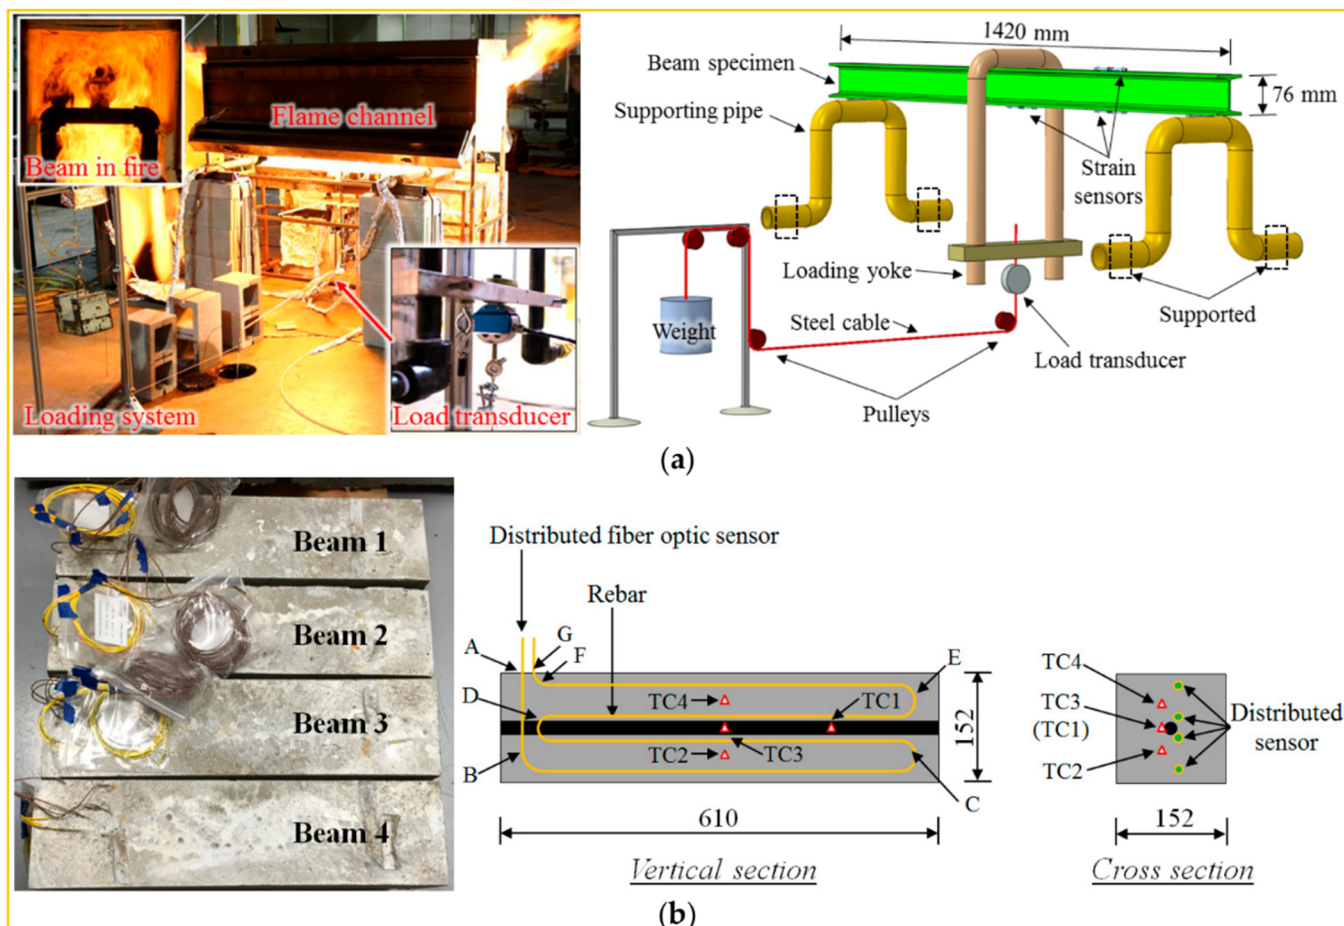
Figure 32. Applications of DOFS in structural fire testing of: (a) Steel beam and (b) RC beams [96].

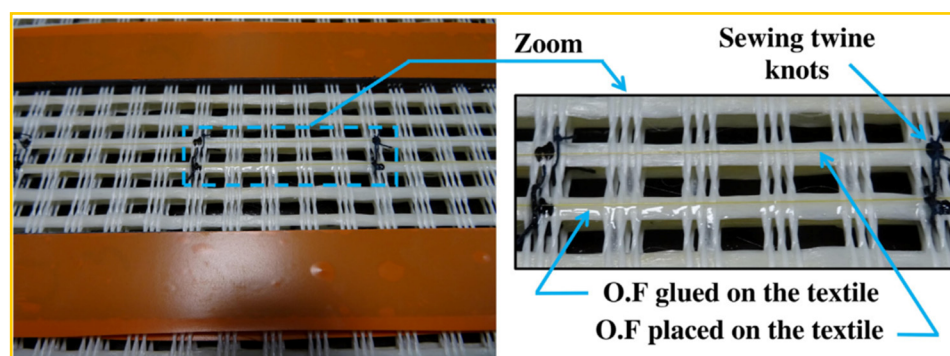
**Figure 33.** Positioning of the optical fiber on the textile reinforcement [98].

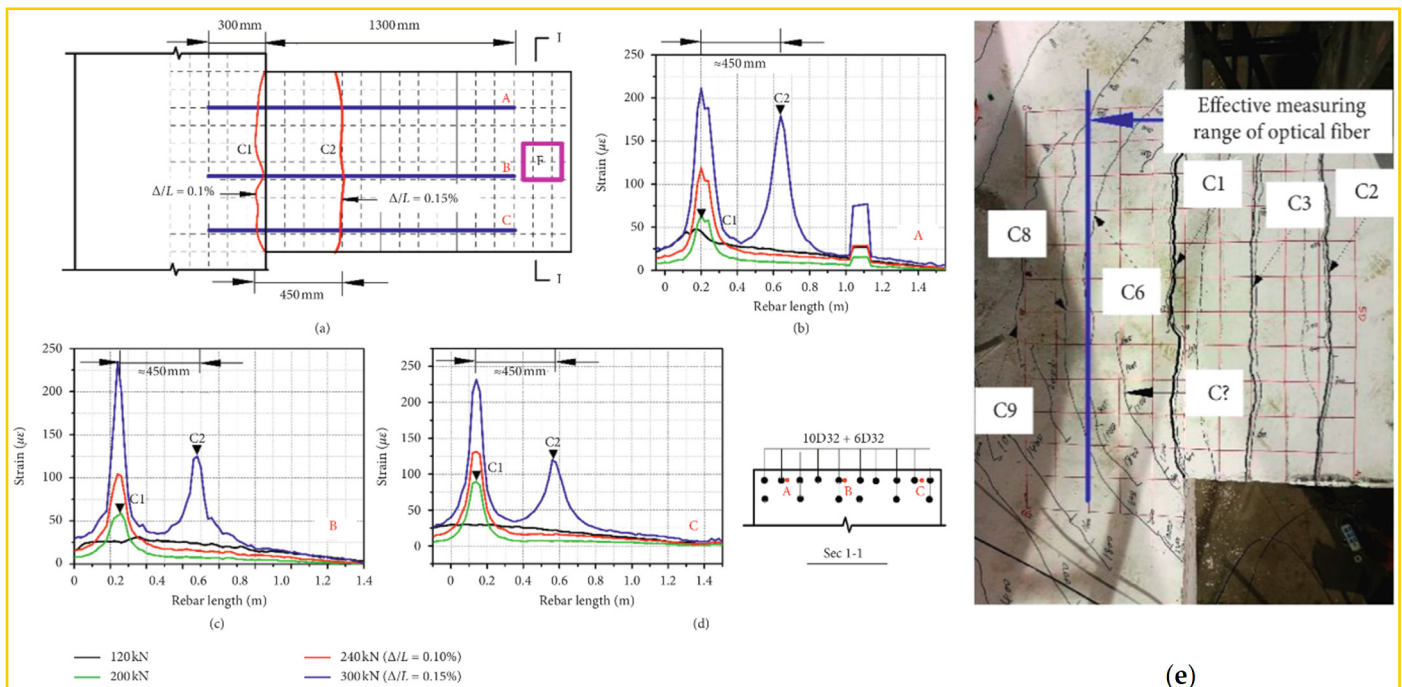
**Figure 34.** (a) Damage status at 0.15% drift, (b–d) are the strain profiles measured in the top fibers A, B and C at drift levels below 0.15% and (e) picture of the cracked specimen (adapted from [100]).

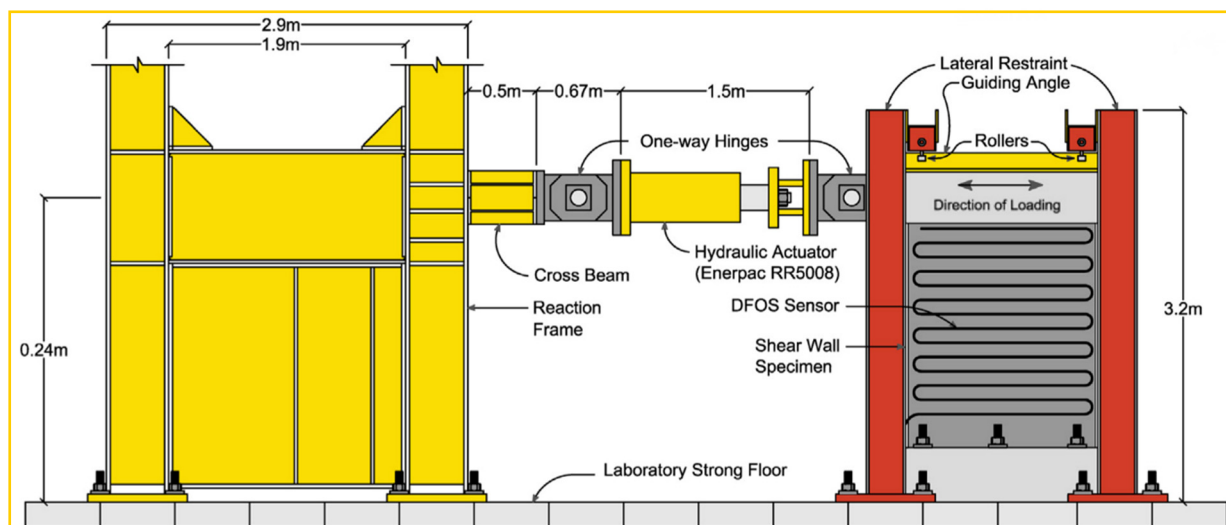
**Figure 35.** Experimental test setup (adapted from [101]).

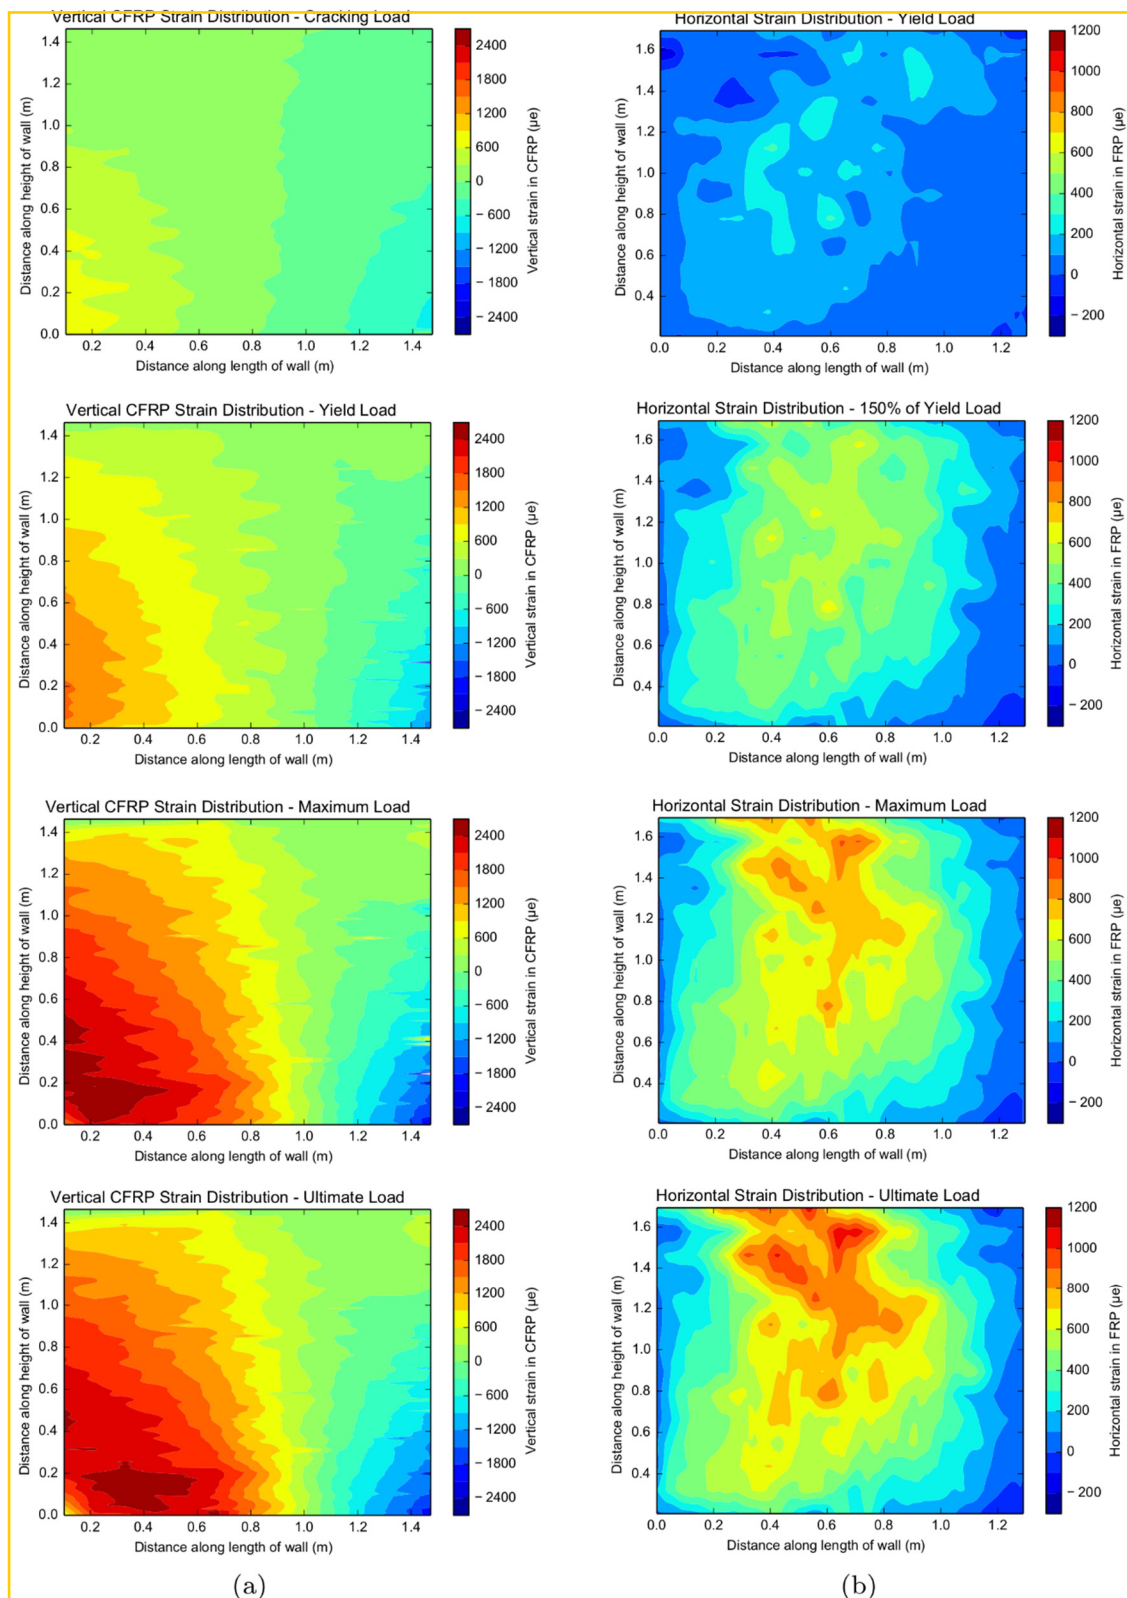
**Figure 36.** 2D spatial strain distribution in the: (a) vertical and (b) horizontal directions [101].

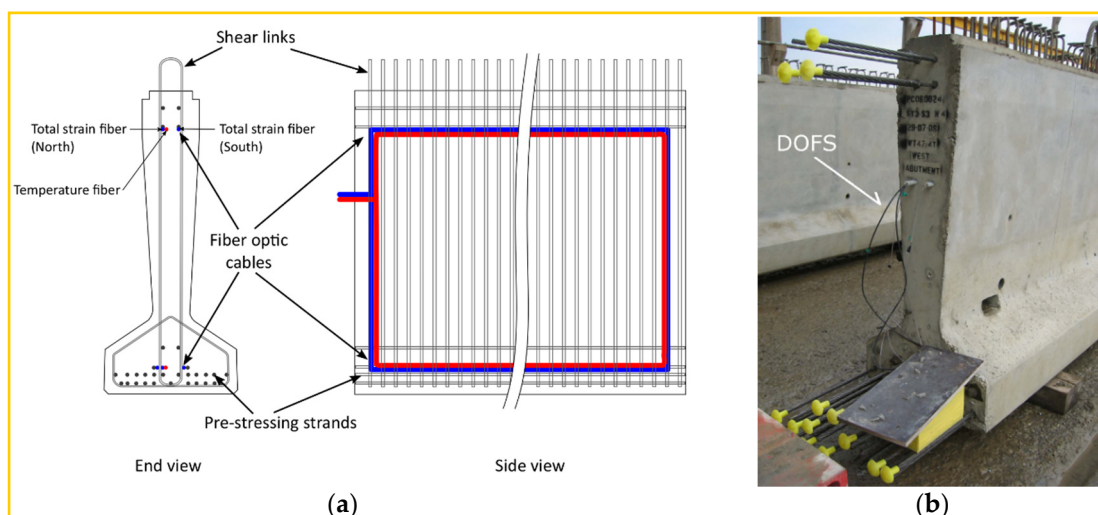
Figure 38. Beam cross section showing the fiber-optic cable locations: (a) illustration and (b) photograph (adapted from [107]).

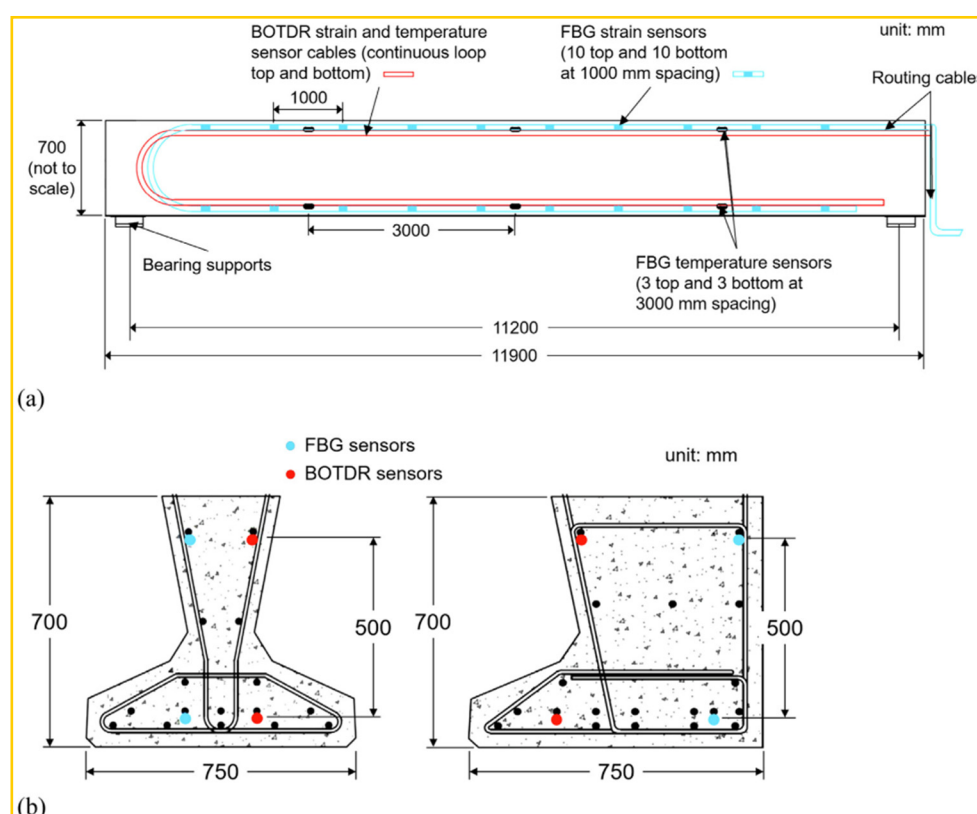
**Figure 39.** (a) DOFS deployment layout and (b) prestressed concrete beam cross-sections—edge TYE7 beams (left) and internal TYE7 beams (right) [110].

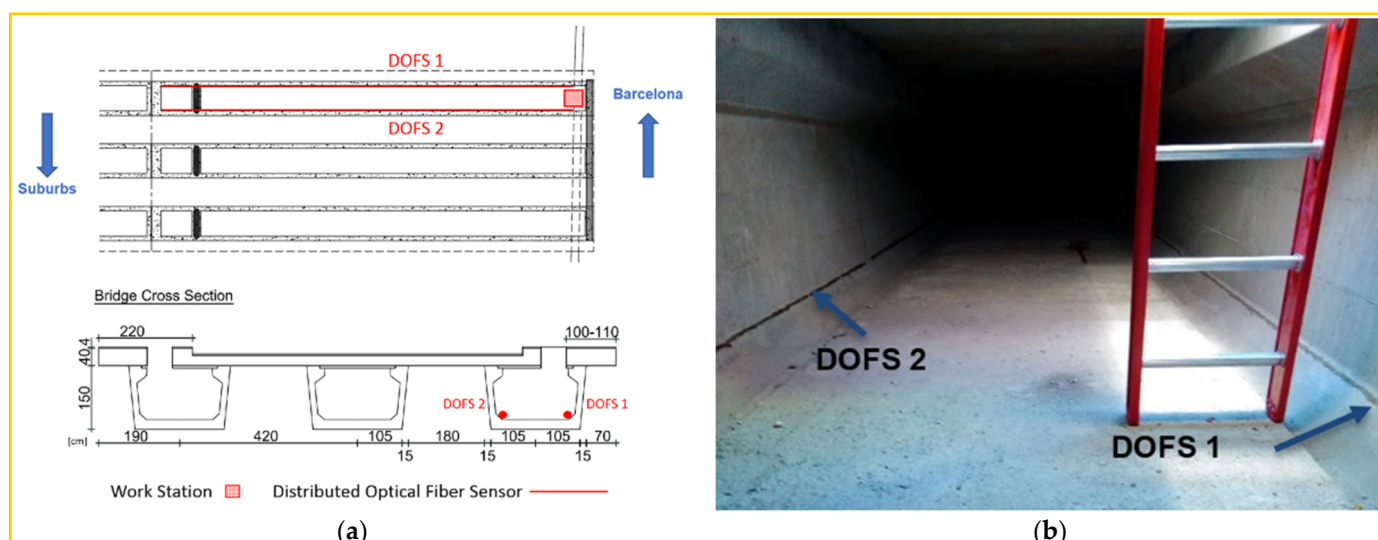
**Figure 40.** (a) General scheme of DOFS monitoring and (b) its photograph inside the box girder (adapted from [111]).

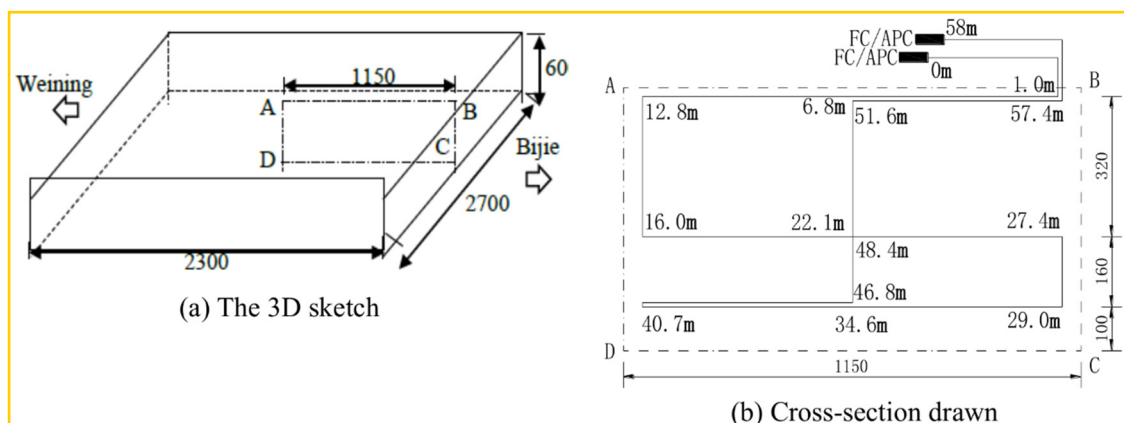
**Figure 41.** (a) A 3D sketch and (b) a cross-section of the DOFS deployment layout for temperature measurements in the study case pile cap [20].

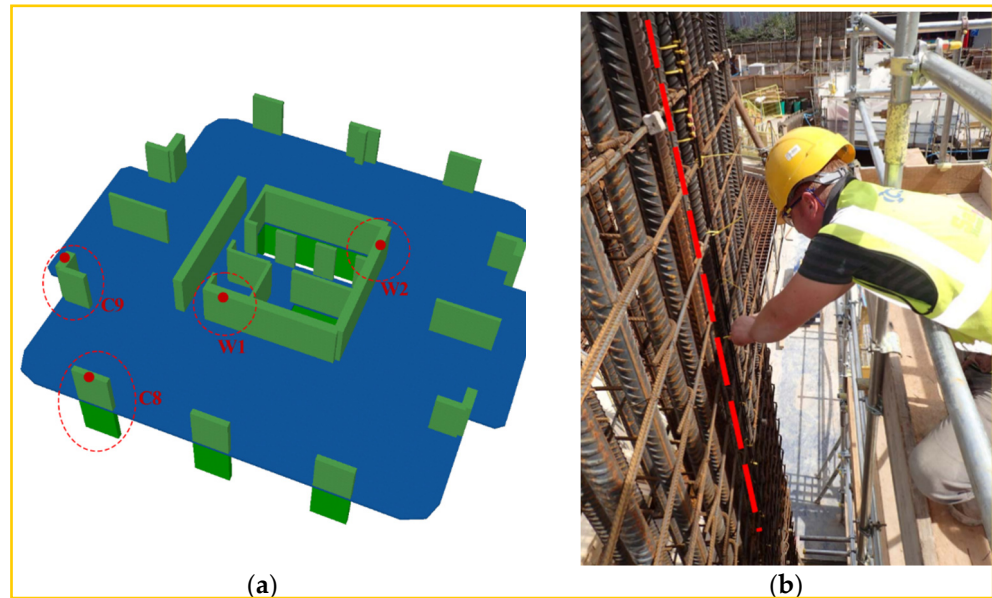
**Figure 43.** (a) Location of the instrumented columns and walls and (b) DOFS tied to the reinforcement prior to concreting [114].

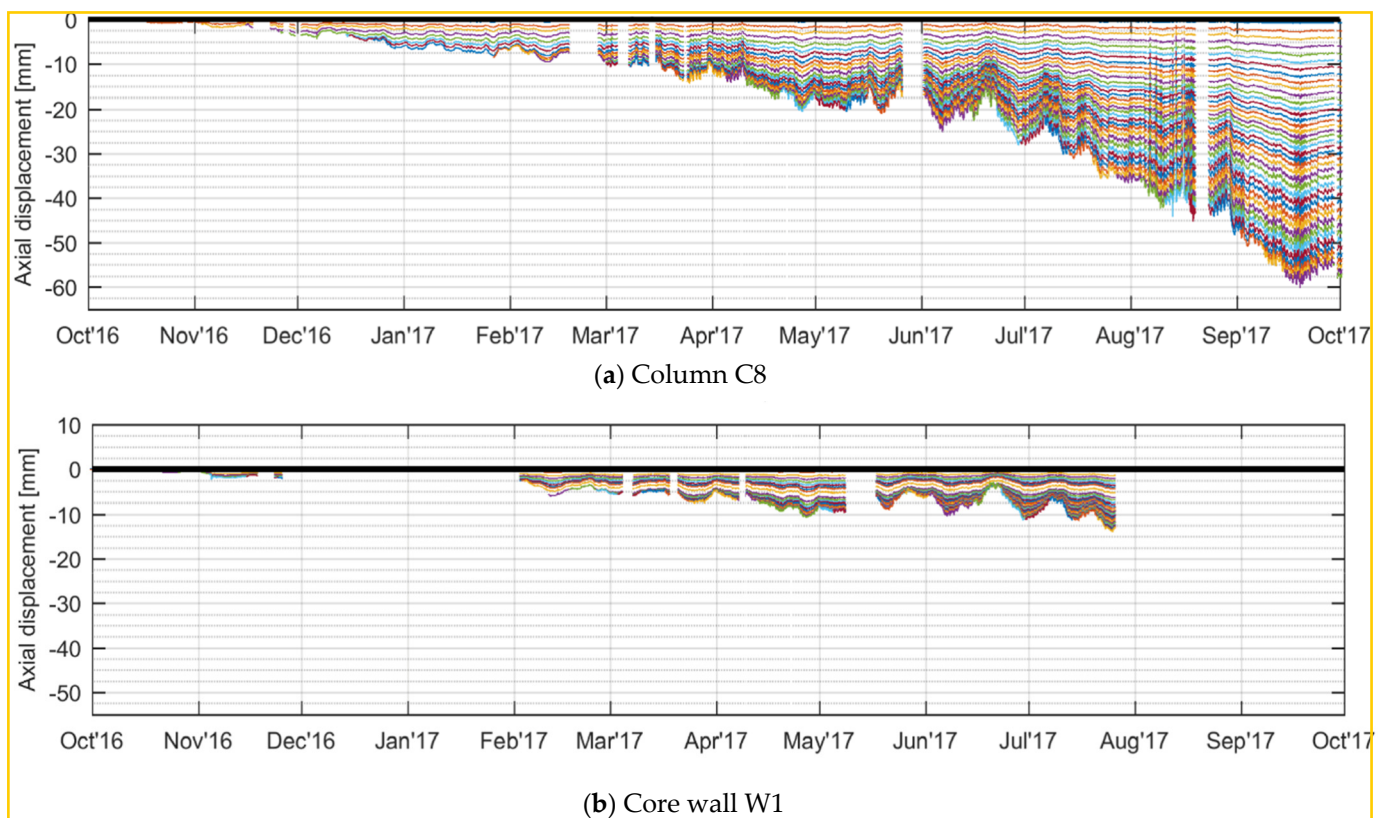
**Figure 44.** The total cumulative axial displacement (negative = shortening) of the instrumented columns C8 and wall W1 measured at the mid-height of every level during the first 12 months of construction (adapted from [114]).

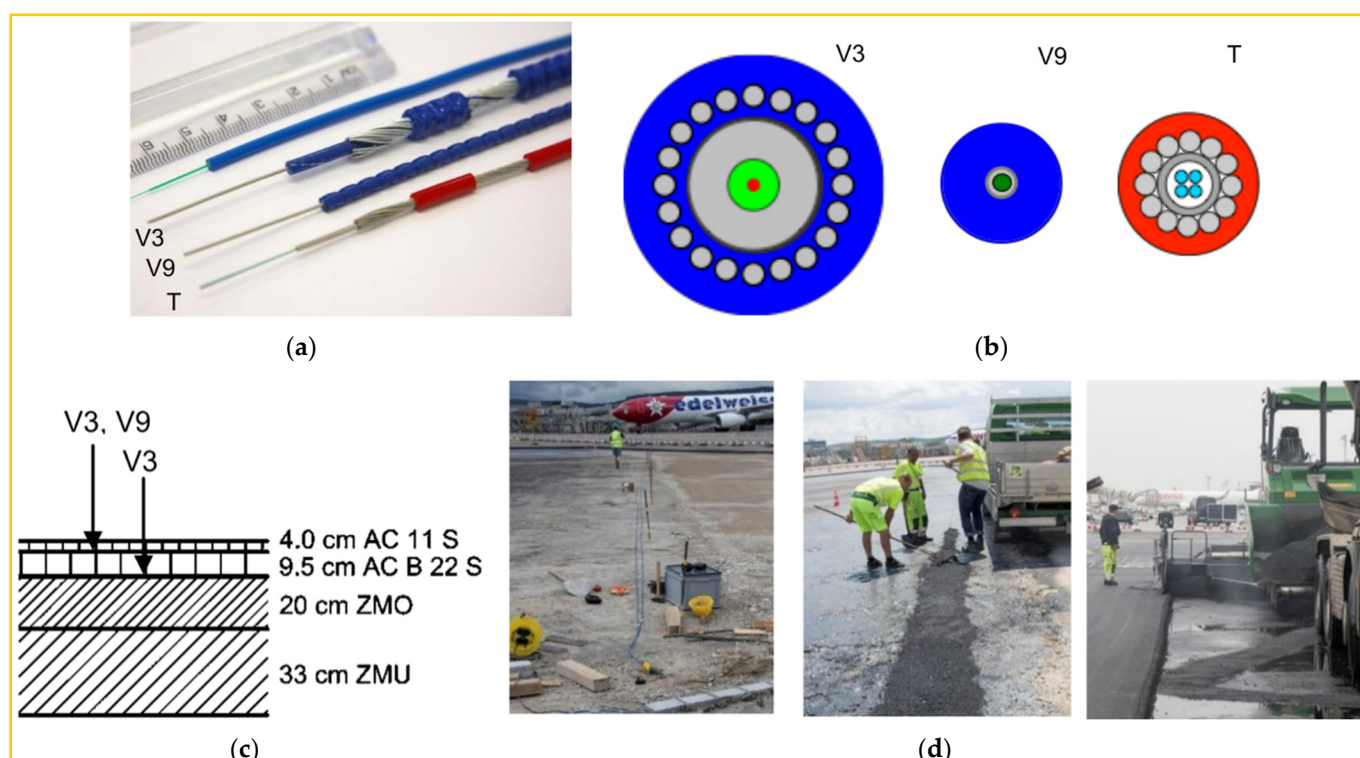
**Figure 45.** (a) Photograph of the DOFS cables, (b) an illustration of their cross-sections and (c) of their designed installation position and finally (d) photography of the deployment process (adapted from [119]).

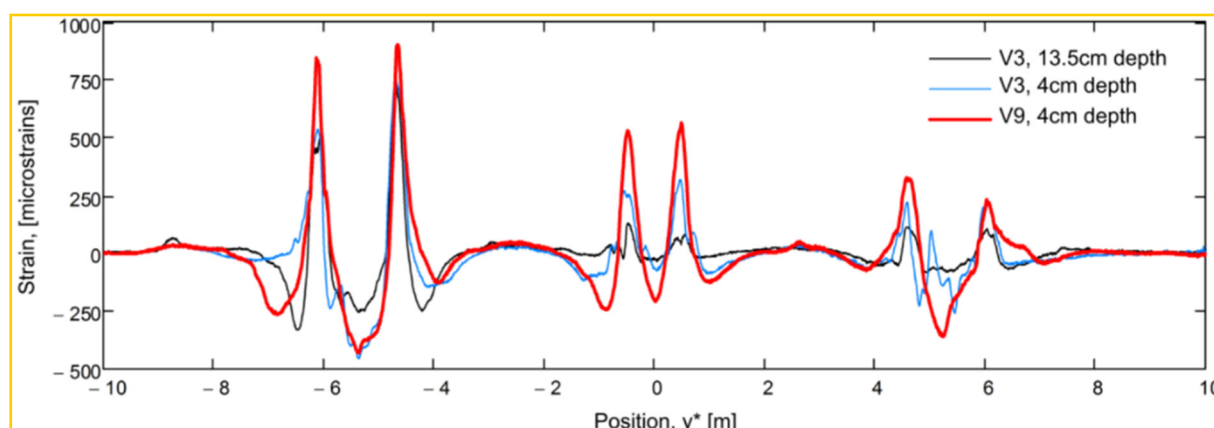
**Figure 46.** Strains measured along the sensors when the study case airplane rear landing gear was rolled on them [119].

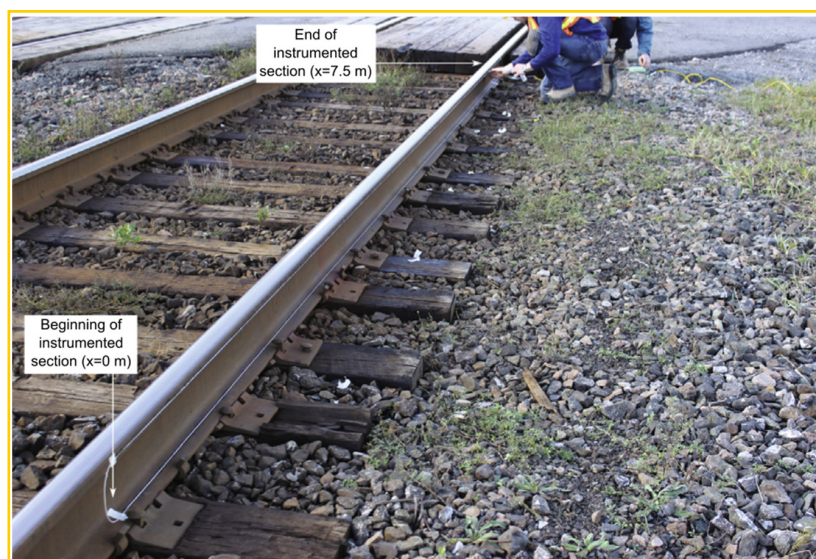
Figure 47. Installation of fiber on rail [120].

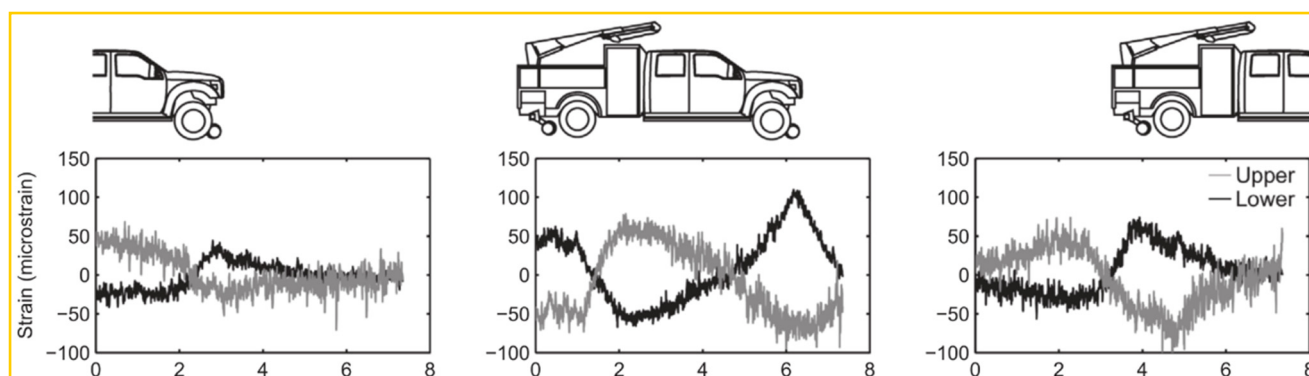
Figure 48. DOFS-sampled strains for three different hi-rail vehicle positions along the track (adapted from [120]).

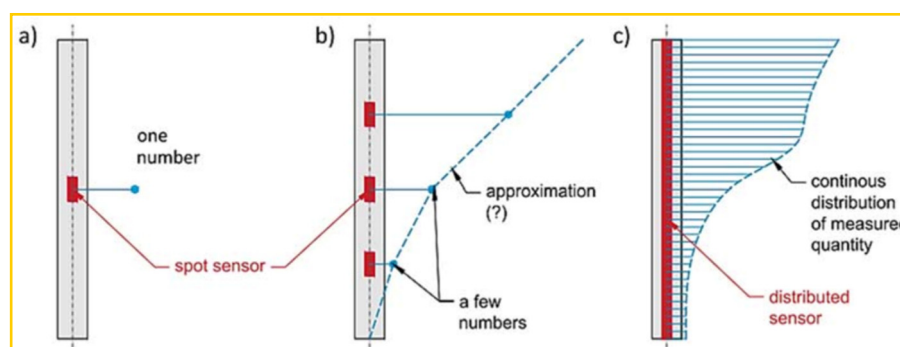
**Figure 49.** Measurement schemes for concrete piles: (a) spot, (b) quasi-continuous, (c) distributed [123].

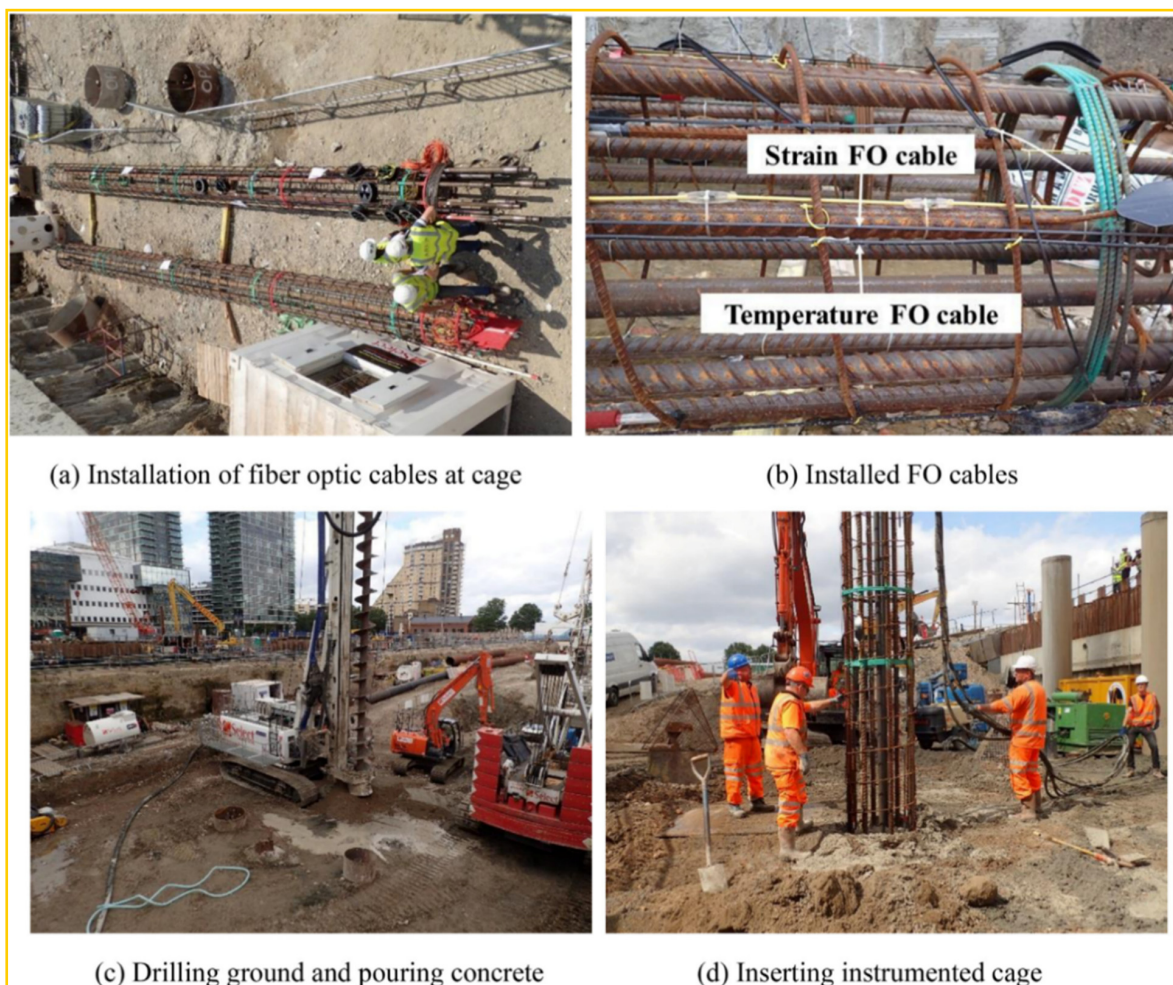
Figure 50. Installation of the DOFS and the pile [7].

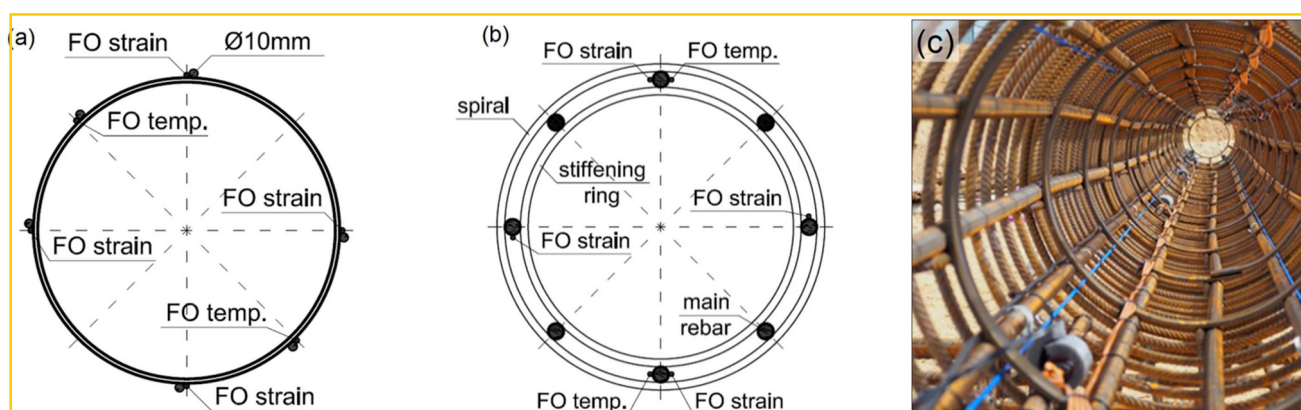
**Figure 51.** Typical cross-section layout of DOFS cables attached to (a) a steel pile and to (b) a steel cage; photograph of the latter is represented in (c) (adapted from [124]).

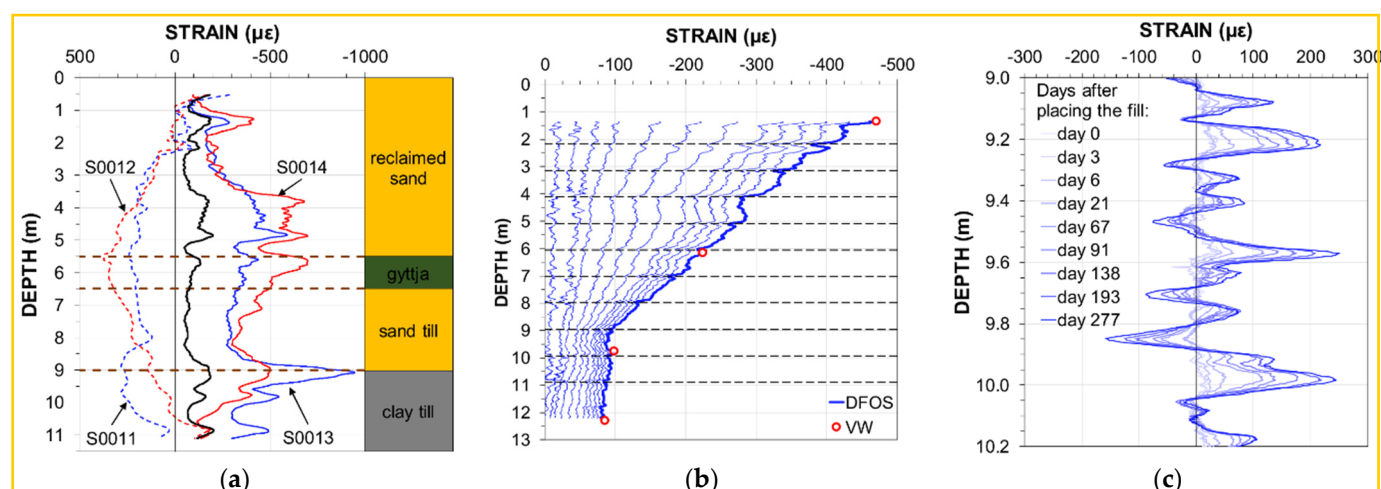
**Figure 52.** Distribution of strains along individual DOFS (a) after the driving of a steel pile (b) during a static load testing of the CFA pile and (c) the crack evolution inside a precast concrete pile (adapted from [124]).

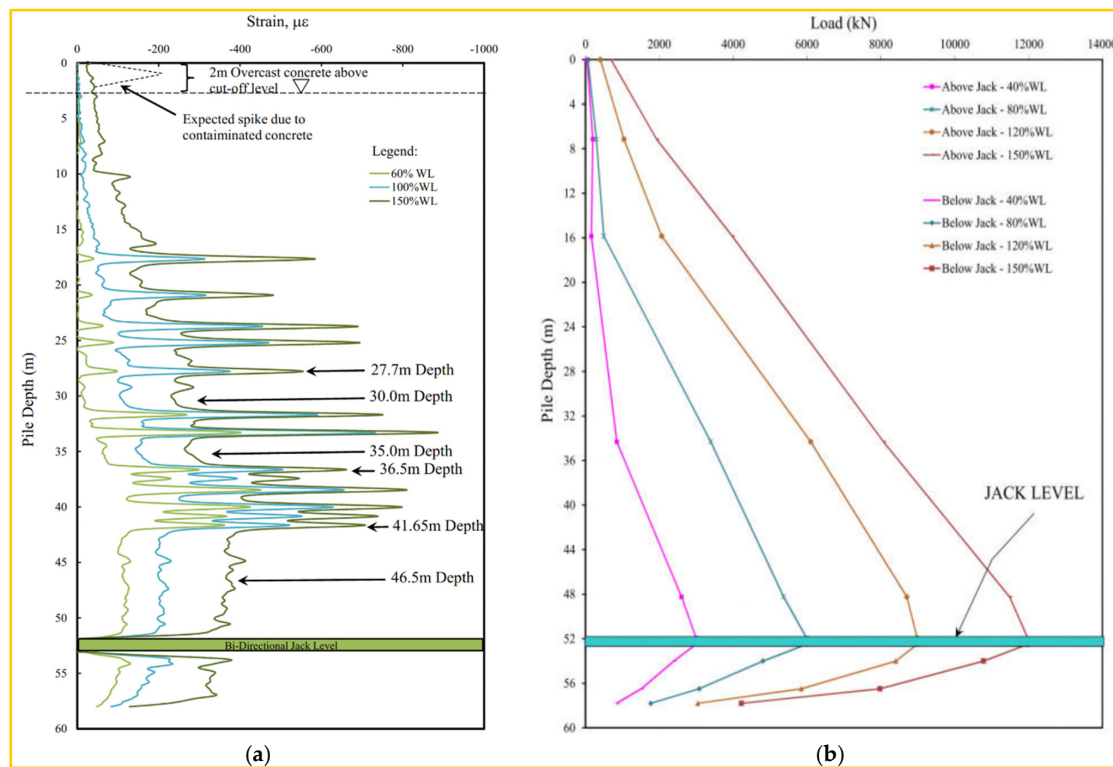
**Figure 53.** (a) Changes in strains along the pile during Bi-Directional Static Load Test (BDSLT) and (b) the calculated load distribution along it (adapted from [125]).

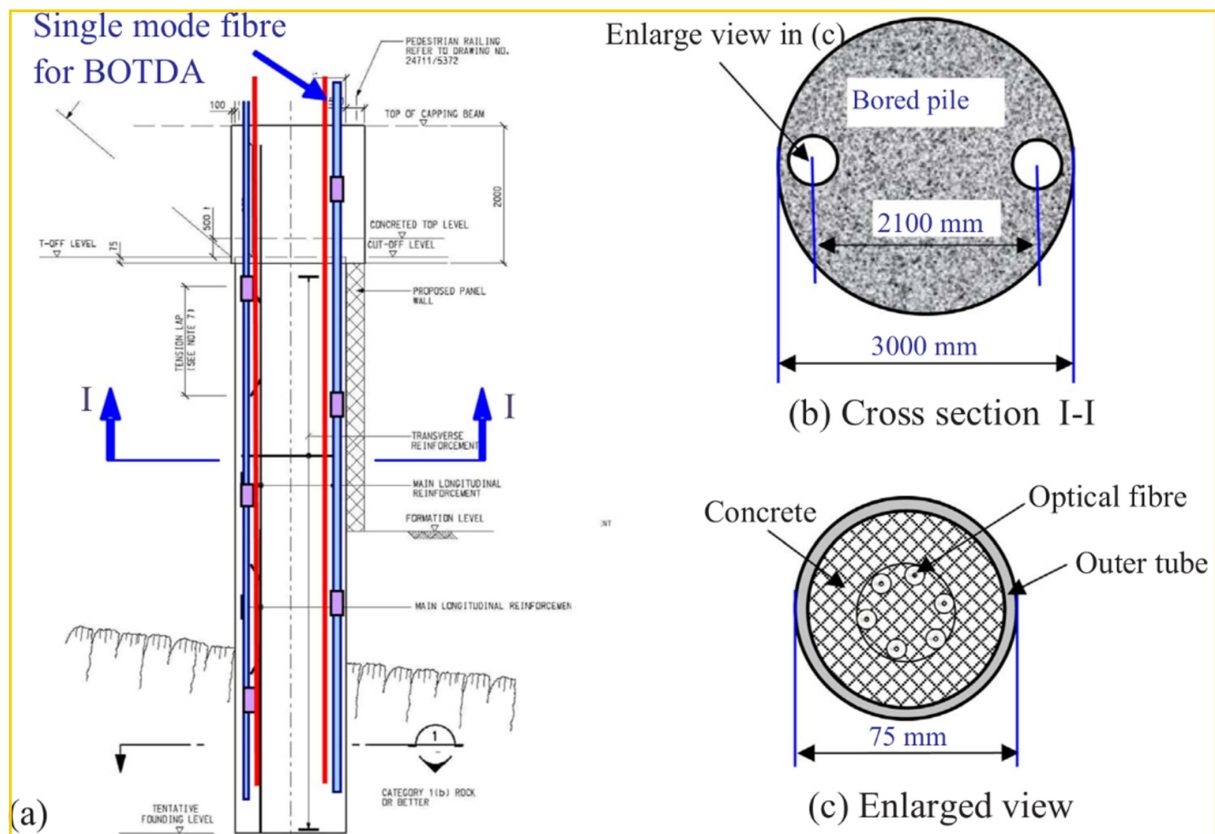
**Figure 54.** Fiber optic deployment layout in the study case bored pile [126]. (a) Total view; (b) Cross section I-I; (c) Enlarged view.

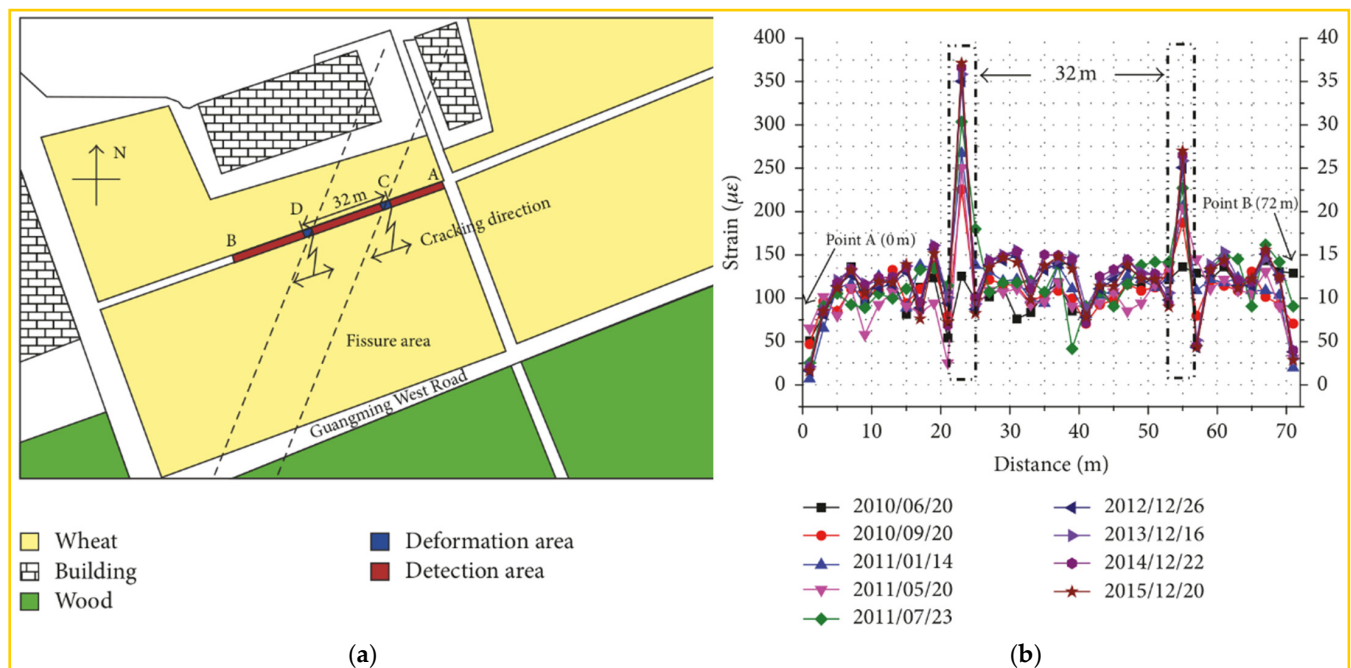
**Figure 55.** (a) Monitoring area plan and (b) resulting strains (adapted from [128]).

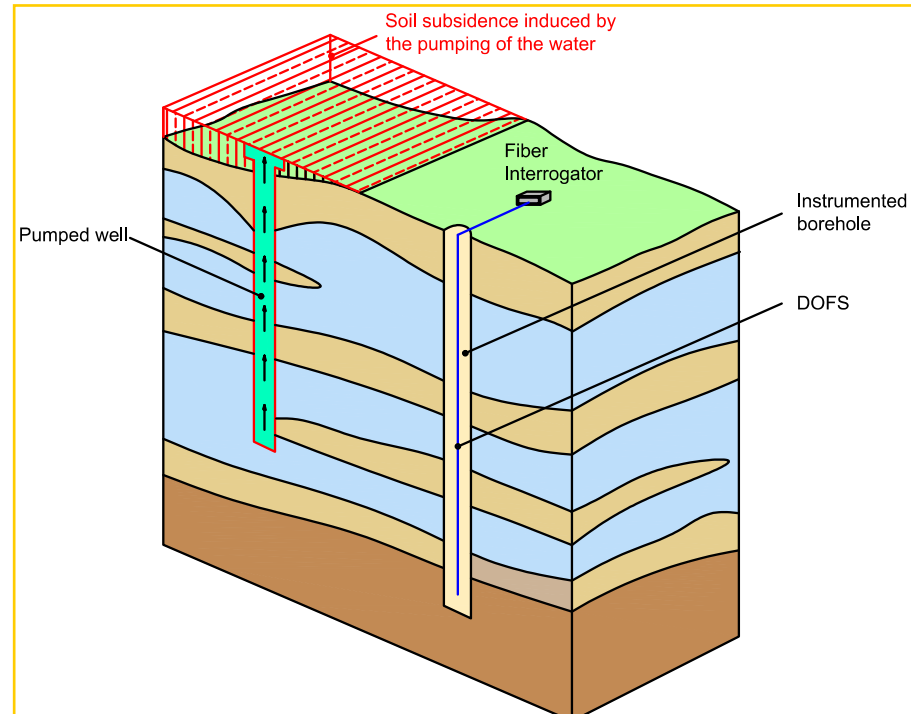
**Figure 56.** Illustration of soil subsidence and DOFS vertical deployment in a borehole as performed in [131].

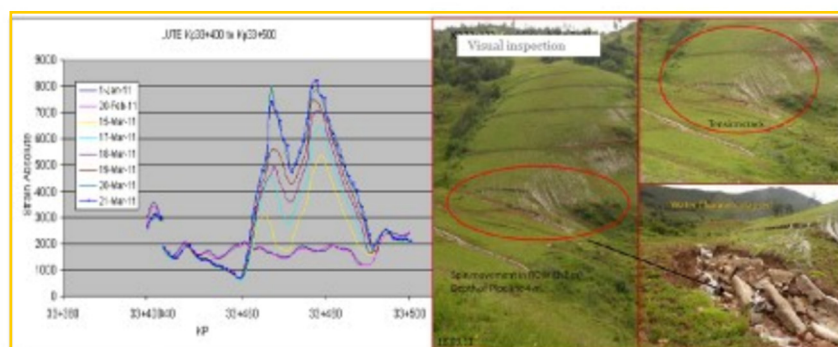
**Figure 57.** Monitoring chart and site map of pipeline trench collapse accident [133].

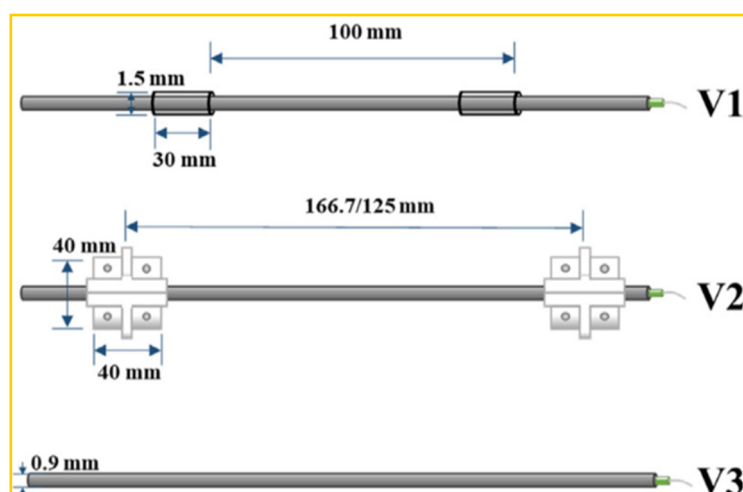
**Figure 58.** Different kinds of anchors used in the test from top to bottom: V1 tube-anchored cable, V2 aluminum block anchored cable, V3 smooth cable [132].

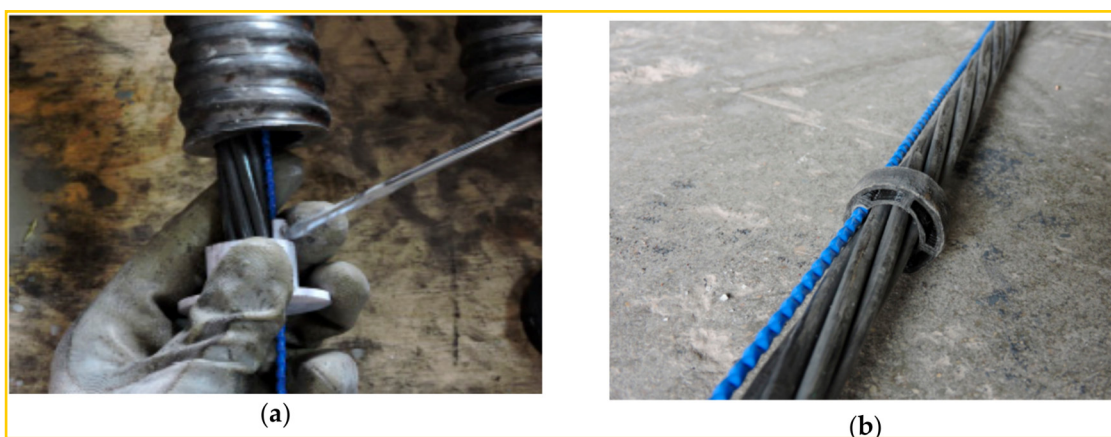
**Figure 59.** DOFS installation by means of plastic hooks for coupling the DOFS in an anchor's (a) extremity bar and (b) internal bar [139].

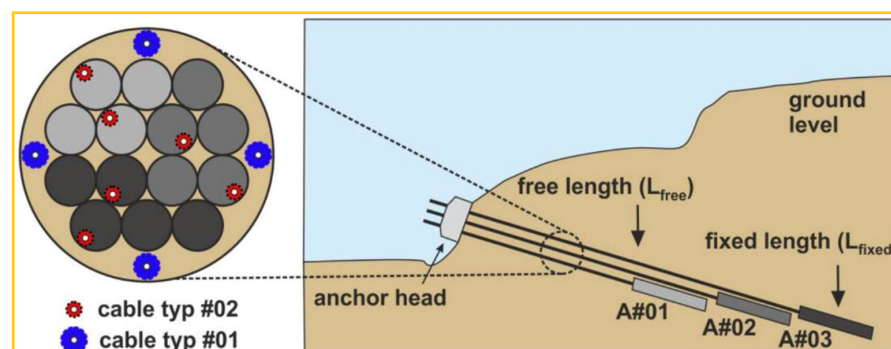
**Figure 60.** Schematic representation of single borehole with multiple anchors and with two DOFS deployed along the tendons of each individual anchor. Two fiber loops were also deployed in the grout material [140].
