# A Review of Recent Distributed Optical Fiber Sensors Applications for Civil Engineering Structural Health Monitoring

**Abstract:** The present work is a comprehensive collection of recently published research articles on Structural Health Monitoring (SHM) campaigns performed by means of Distributed Optical Fiber Sensors (DOFS). The latter are cutting-edge strain, temperature and vibration monitoring tools with a large potential pool, namely their minimal intrusiveness, accuracy, ease of deployment and more. Its most state-of-the-art feature, though, is the ability to perform measurements with very small spatial resolutions (as small as 0.63 mm). This review article intends to introduce, inform and advise the readers on various DOFS deployment methodologies for the assessment of the residual ability of a structure to continue serving its intended purpose. By collecting in a single place these recent efforts, advancements and findings, the authors intend to contribute to the goal of collective growth towards an efficient SHM. The current work is structured in a manner that allows for the single consultation of any specific DOFS application field, i.e., laboratory experimentation,

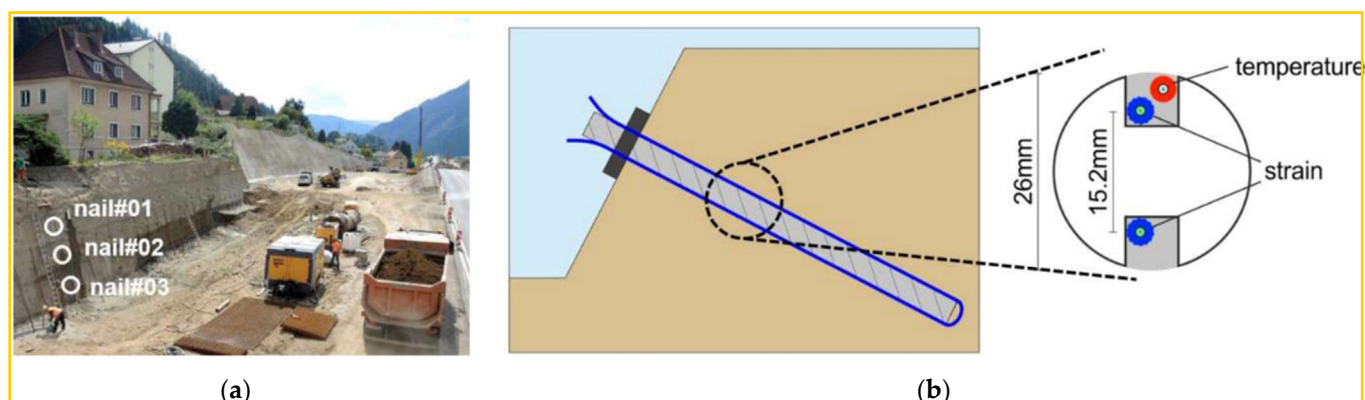
**Figure 61.** (a) Three fiber optic-instrumented soil nails at a construction site and (b) their cable layout [140].

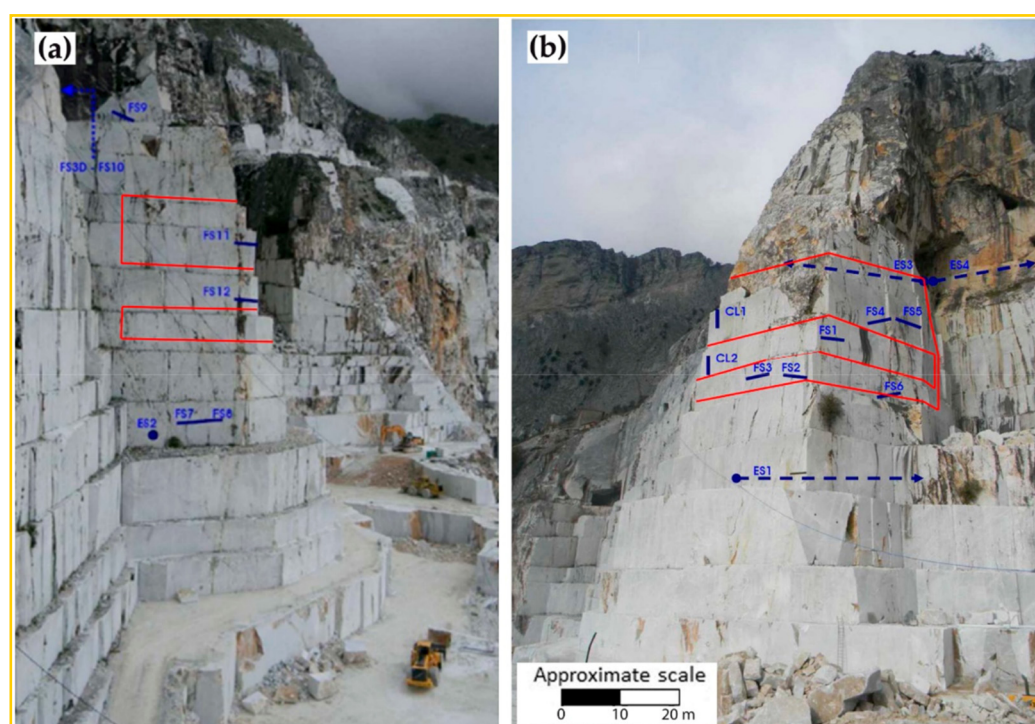
**Figure 62.** Geotechnical sensors (in blue) and fiber optics cable (in red) on the western (a) and southern-eastern (b) sides of the buttress [142].

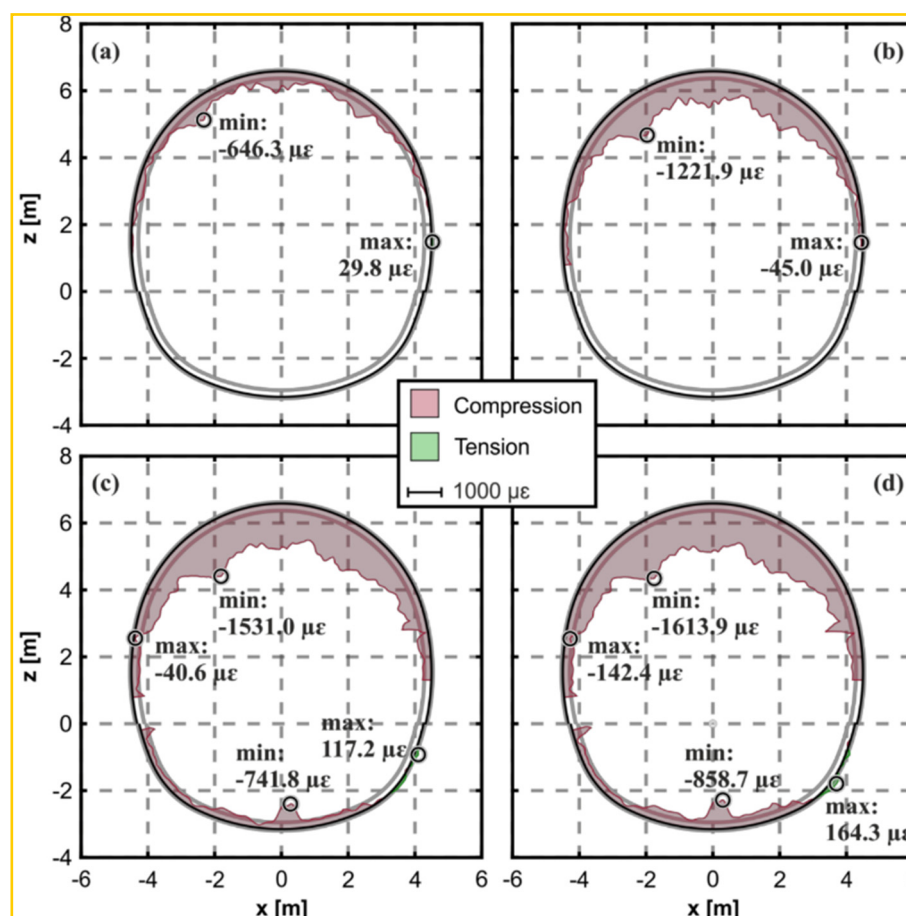
**Figure 64.** Measured strain distribution at the rock-side layer in peripheral direction: (a) 12 h after installation at top-heading, (b) 48 h after installation at top-heading, (c) 12 h after installation at invert and (d) 48 h after installation at invert [147].

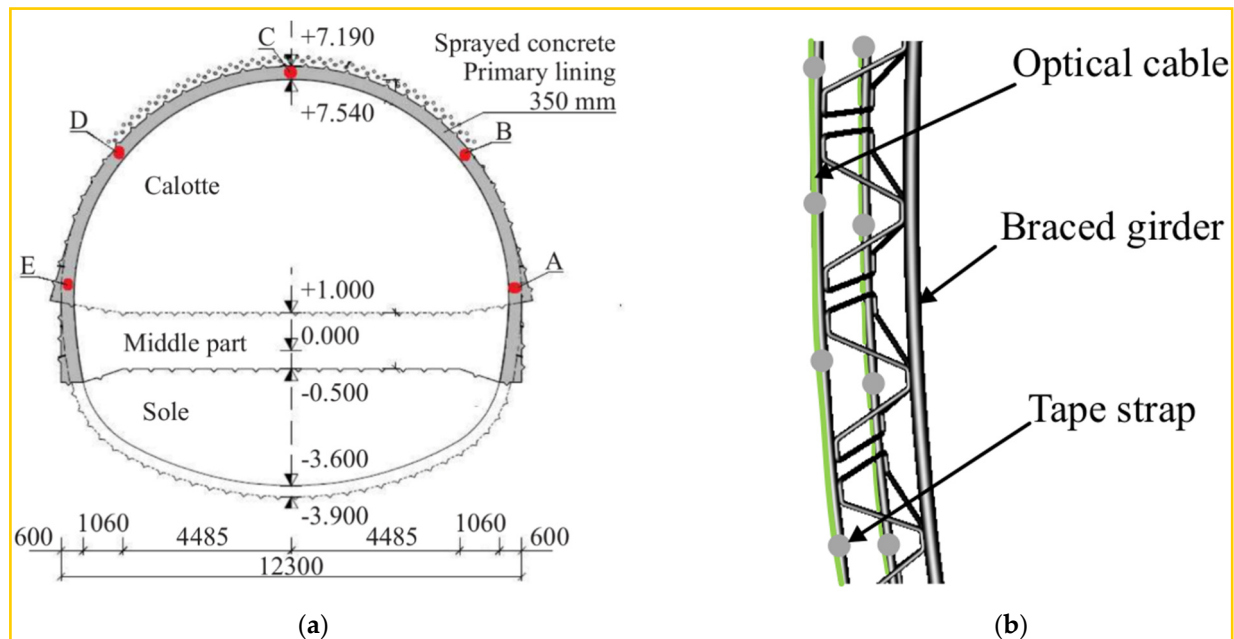
**Figure 65.** (a) Tunnel and distributed temperature and strain system layout and (b) optical fiber implementation on iron bars of the braced girder of the primary lining [146].

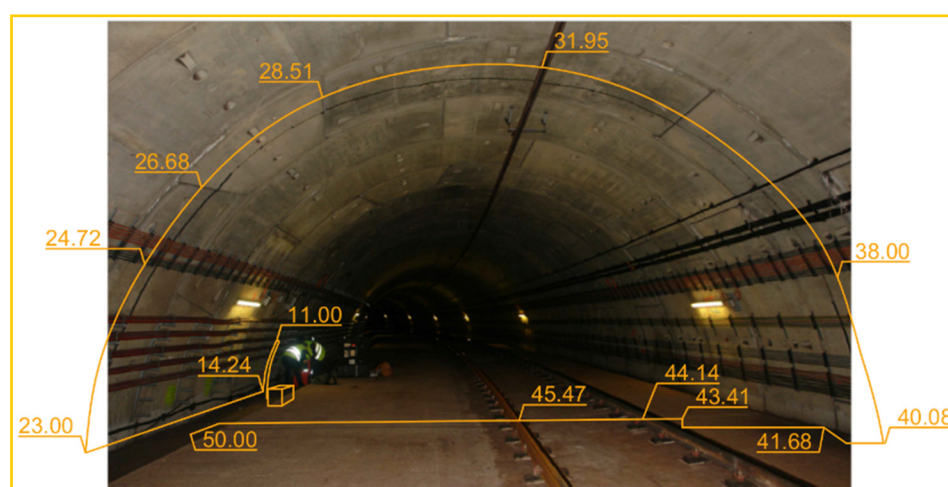
**Figure 66.** Monitored tunnel section [150].

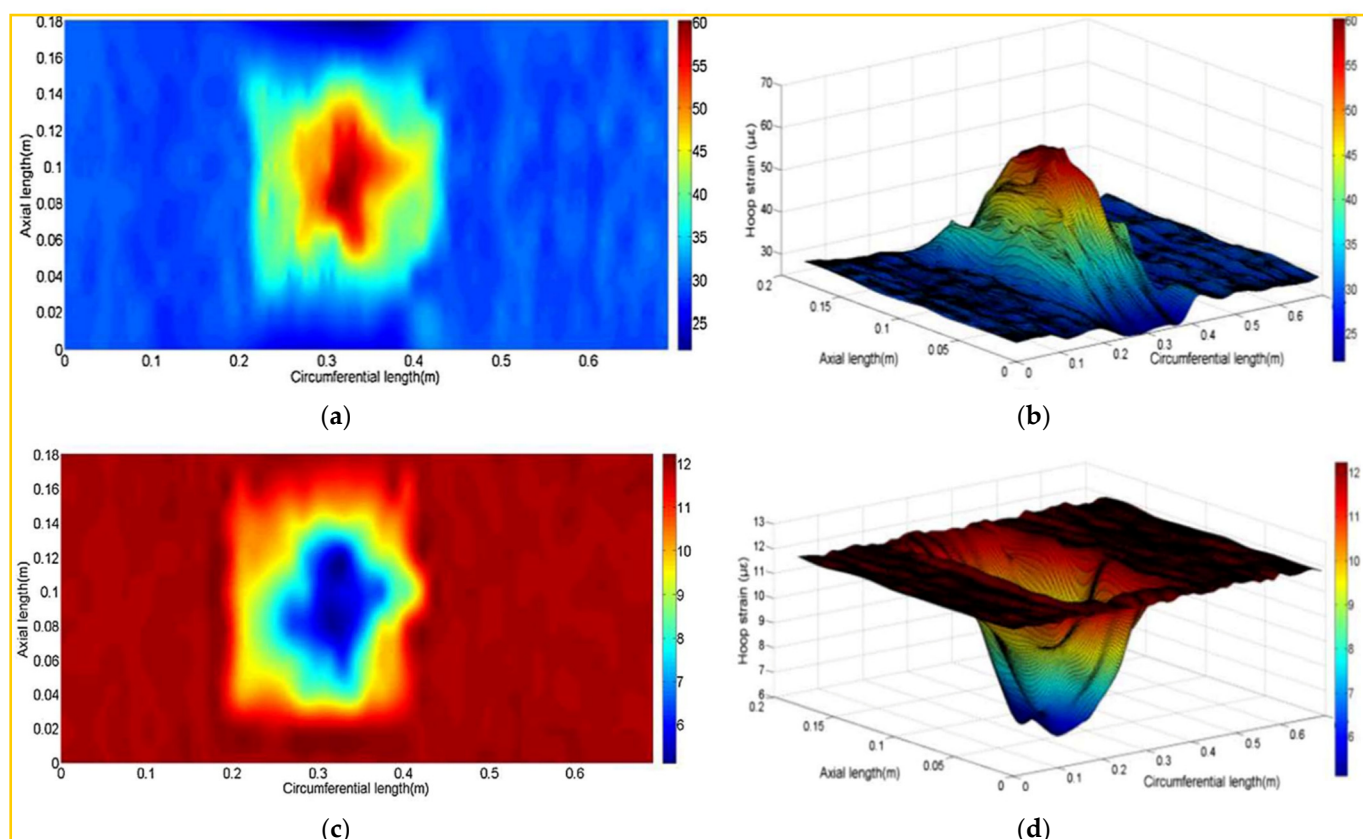
**Figure 67.** Hoop strain nephogram when the pipe was corroded at 200 h (a) 2D and (b) 3D and wall thickness nephogram when the pipe was corroded at 200 h (c) 2D and (d) 3D. [158].

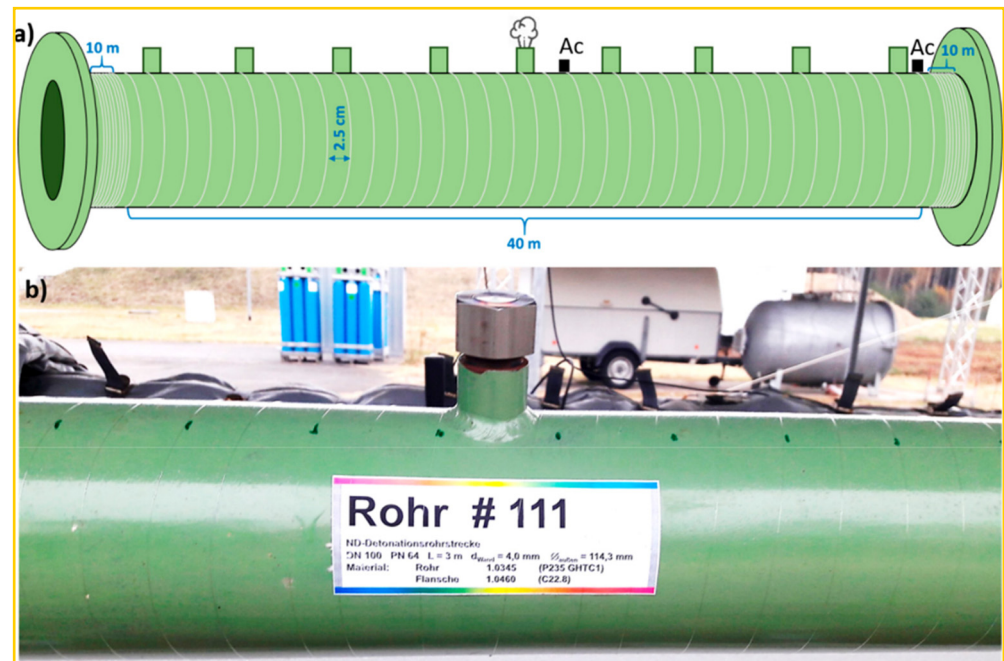
**Figure 68.** (a) Schematic illustration of the fiber helical wrapping around the pipe segments and (b) photo of one of the pipe's side adapters [159].

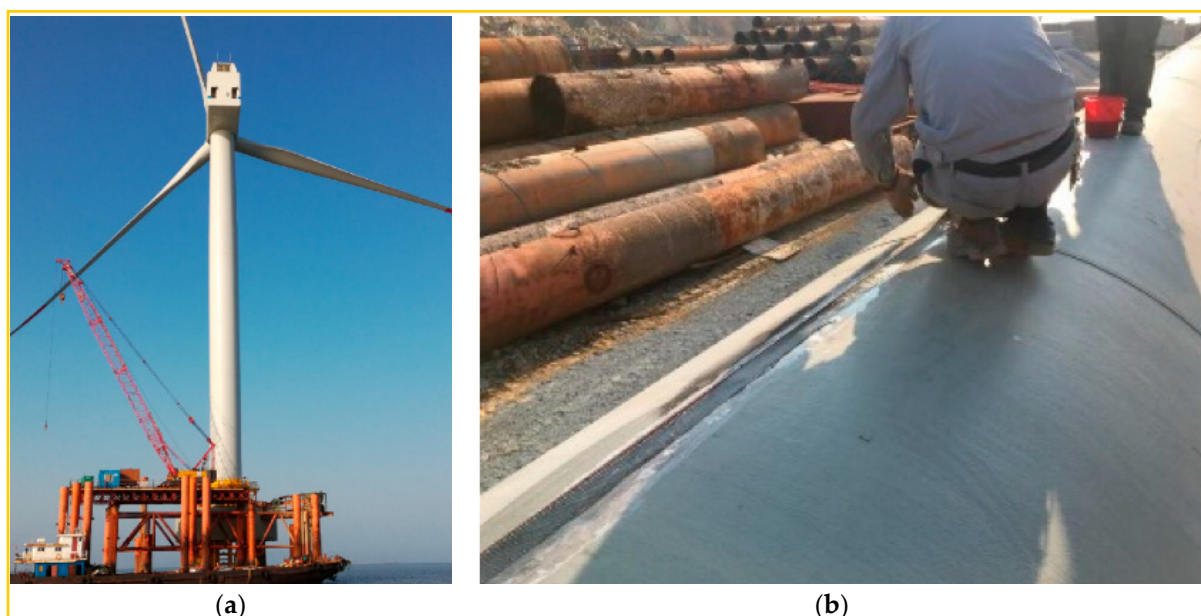
**Figure 69.** (a) Study case offshore turbine (b) DOFS bonded with epoxy to the sample pile (adapted from [26]).

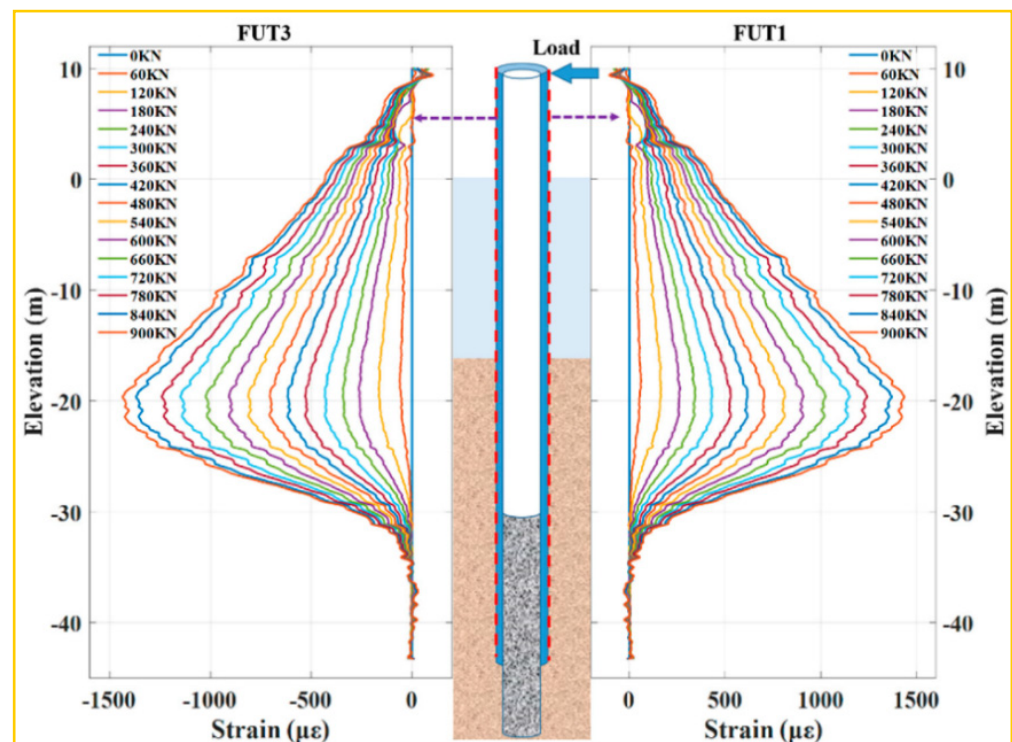
Figure 70. Strain values per corresponding elevation from 0 kN to 900 kN [26].

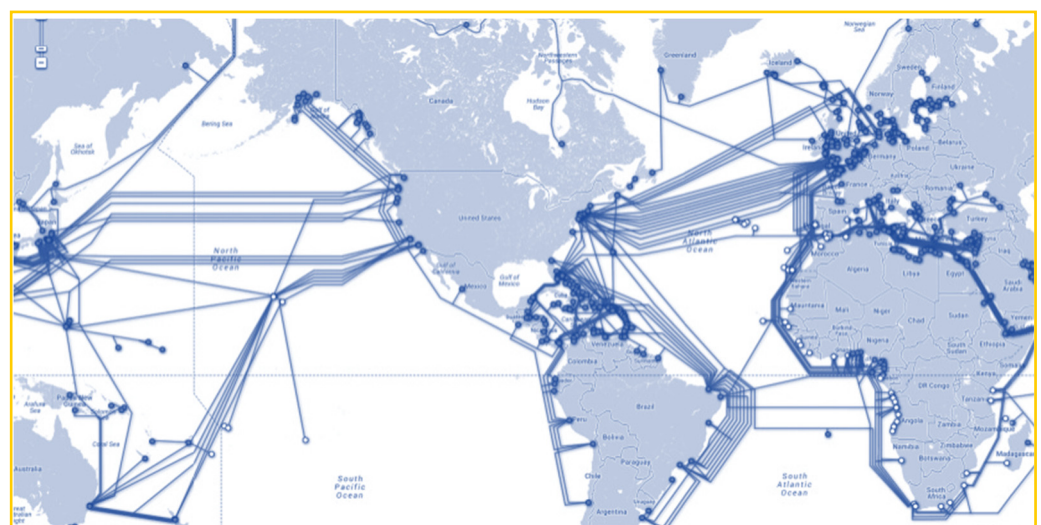
Figure 71. Submarine cable map in 2015 [166].

For example, Fernandez-Ruiz et al. [28] introduced the idea of using the already-existing world-wide telecommunication fiber optic network (Figure 71) for continuous, real-time monitoring of the global surface on the lookout for any seismic activity.

By means of the optical fibers' ubiquity and ability to perform distributed and highly sensitive DAS vibration monitoring, it would be possible to recognize patterns of potentially hazardous seismic activity. In particular, the authors tested the feasibility of such a plan

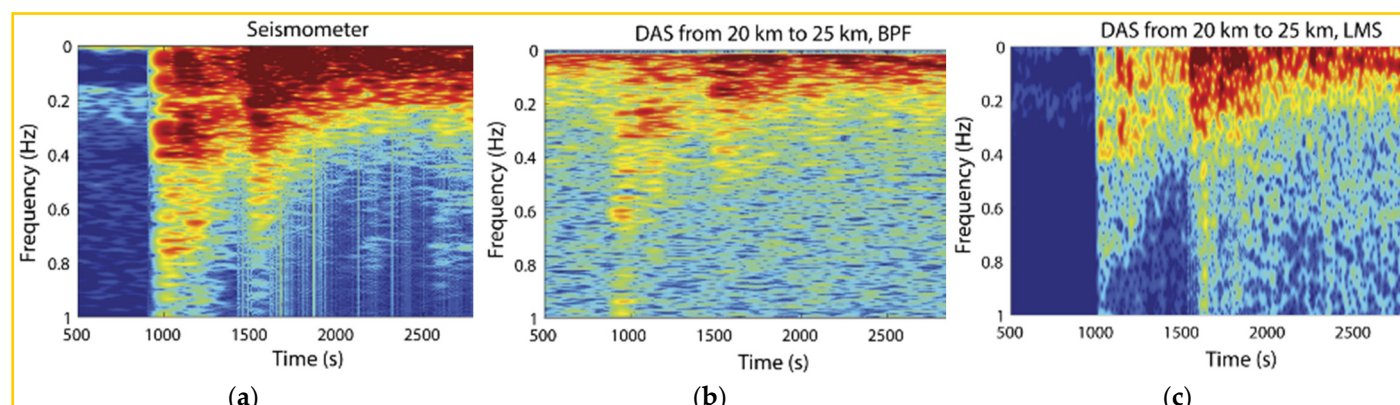
**Figure 72.** (a) Spectrogram of the seismic signal measured by a reference seismograph (b) Spectrogram of the DAS data denoised with a 2D linear bandpass filter and a (c) Spectrogram of the DAS data denoised with a 1D adaptive LMS filter (adapted from [28]).

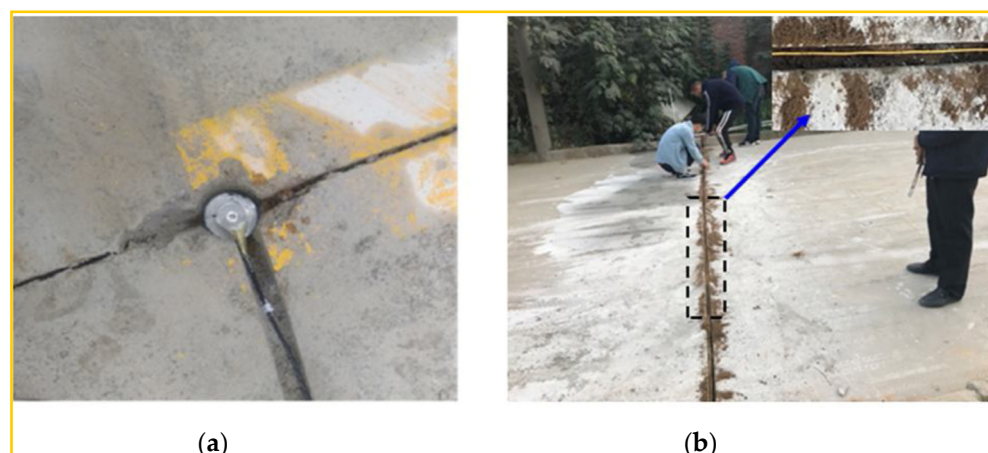
**Figure 73.** (a) Fiber Bragg Grating (FBG)-based acceleration sensor and (b) Distributed Optical Fiber Vibration Sensor [52].

Distributed Optical Fiber Vibration Sensors, essentially DAS, and FBG were installed on a road pavement to form a load identification system (as in Figure 73).

The authors reported that the test, carried out for four vibration loads (rockfall impact, motorcycle, automobile and concrete tanker), showed that both the DAS and the FBG-based acceleration sensors could successfully identify the different loads.

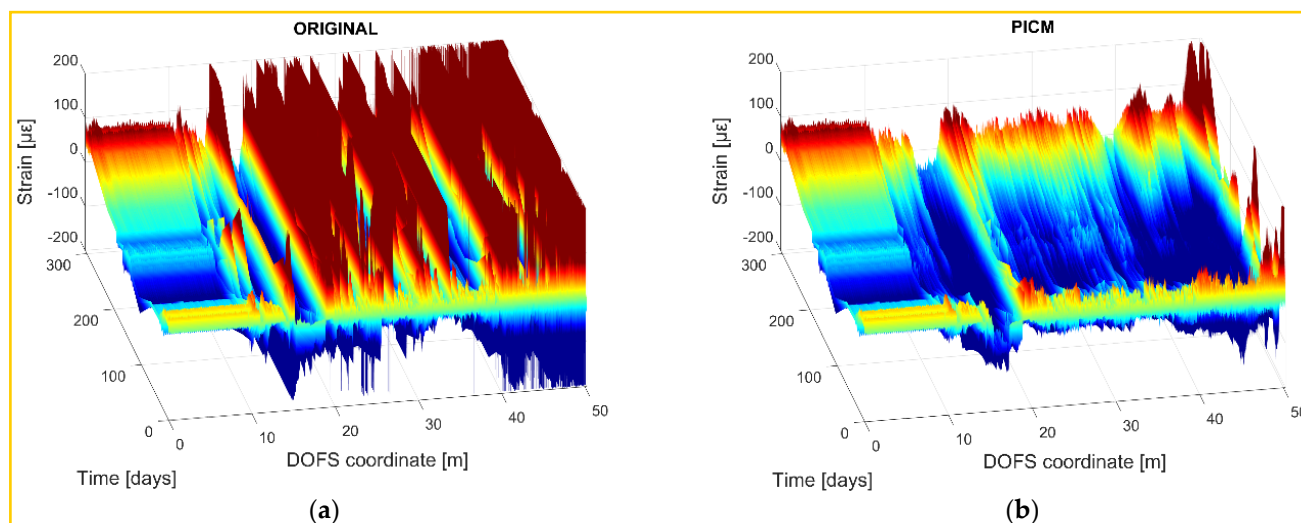
**Figure 74.** DOFS extracted strain evolution in time: (a) before post-processing and (b) after post-processing with PICM—Polynomial Interpolation Comparison Method.
